DAMP INSPECTION REPORT

On:
Flats 20 & 23 Great Cliff
Marine Parade
DAWLISH
EX7 9EX

30 January 2023

Croft Surveyors Ltd
No. 3 Little Priors Offices
Fore Street
Totnes
Devon
TQ9 5NJ

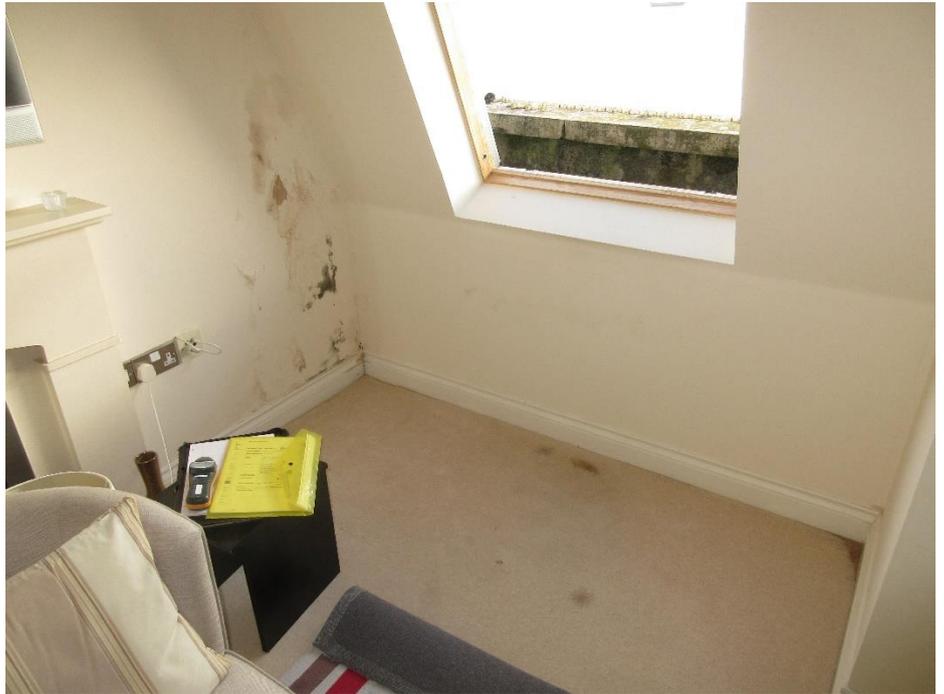
The flank walls to either side of Flat 20 are suffering from penetrating damp causing staining and deterioration in internal plasterboard dry-lining at their junctions with the front wall of the mansard roof. This is causing significant damage to plasterwork finishes, especially to the northern party wall.

In addition, the concrete floor of Flat 20 is very wet, at its junction with the front wall of the mansard alongside the northern party wall in the sitting room. This is causing staining and deterioration in the carpets and skirting boards.

Fig.1 Damp damage in Flat 20

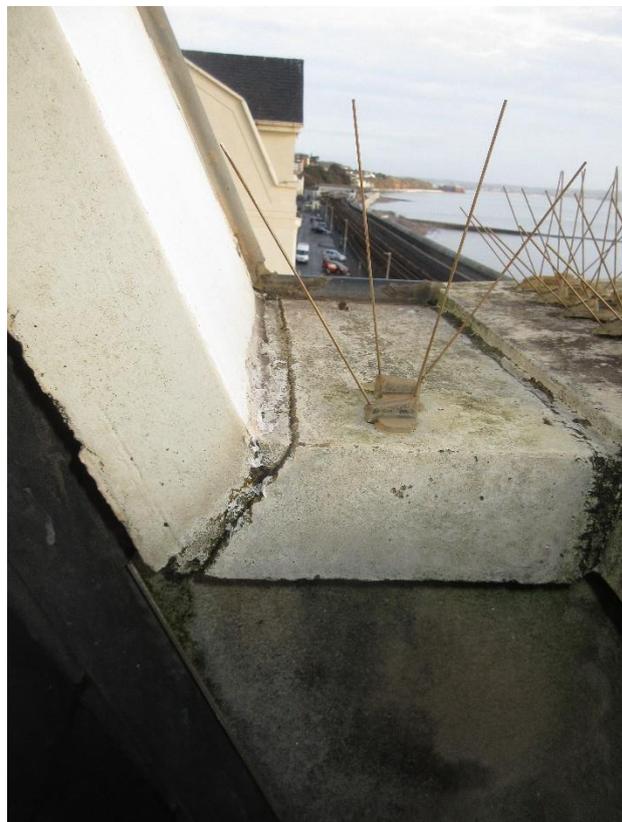
The coping stones to the parapets have some open cracks in their mortar-pointed joints which will allow a little water to penetrate. There should be a damp proof course (DPC) beneath the coping stones, to protect against absorbed rainwater from soaking down through the masonry to affect internal walling, although without removing the coping stones this can't be verified.

Attempts have been made to improve weatherproofing including silicone sealant smeared across joints and an odd metal or PVC upstand fixed to the outside edge of the coping stone over the worst affected northern party wall to Flat 20.

Conjecturally, it is possible that the grey plastic or metal upstand that has been added to the parapet coping over Flat 20 is actually trapping wind-driven rainwater, exacerbating the problem.

Fig.2 Parapet copings stones have cracks in joints into which water can penetrate, possibly exacerbated by the metal or PVC trim added.

To address it requires proper investigation requiring scaffold access. The affected coping stones would ideally need removing and new damp proof courses installing beneath. Another possibly simpler option might be to instead cap all the parapet copings in traditional welted lead-sheet, which is guaranteed weathertight, and lasts many decades.

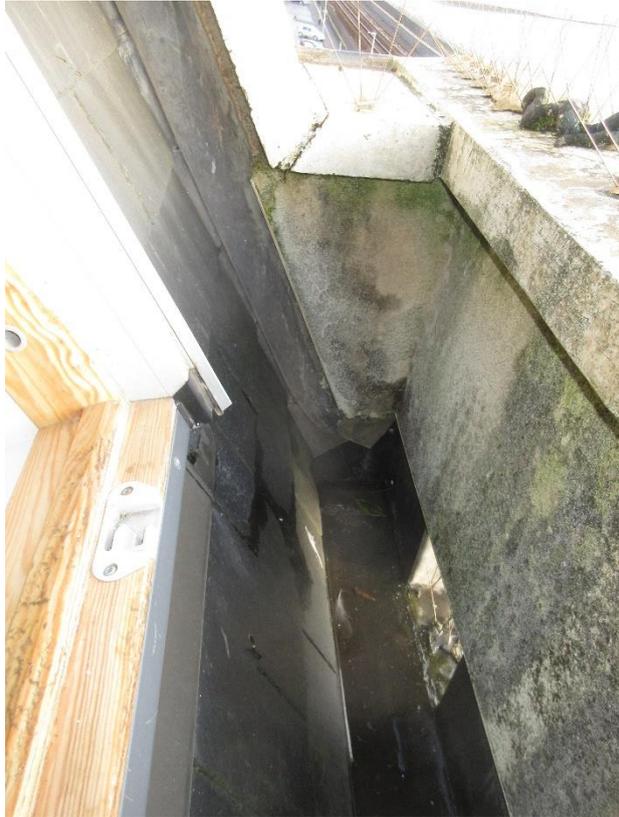
The box gutter behind the front parapet to the northern side of Flat 20 is lined in a black single-ply PVC membrane. We noted that this was partially collapsed, causing it to hold water, and the soft and 'squidgy' feel to the base of the gutter suggests that supporting timber layboards have decayed and failed.

Fig.3 Parapet box-gutter lining appears to be partially collapsed and leaking, saturating the concrete floor of the flat.

The damp affecting the floor of Flat 20 appears to be instead caused by a leak in the single-ply membrane lining to the parapet box gutter immediately in front. This will need stripping out and re-lining, along with replacing the decayed timber supporting lay-boards beneath. This will again require scaffold access and should therefore be combined with the recommended works to the parapet copings.
