REGULATORY REFORM (FIRE SAFETY) ORDER 2005 FIRE RISK ASSESSMENT

Great Cliff Dawlish Ltd
Great Cliff
Marine Parade
Dawlish
Devon
EX7 9EX

REPORT UNIQUE IDENTIFIER: 1642

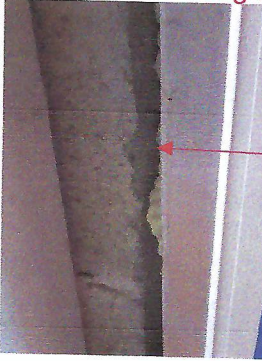
<p>5.</p>	<p>Premise's compartmentation & fire stopping: <i>Residential common circulation areas, i.e. stairways, corridors and lobbies:</i> Riser cupboard door frames: Fire stopping should be applied to the reverse side of each riser cupboard door frame to fixing wall.</p>

<div data-bbox="805 985 1197 1131" style="border: 1px solid black; padding: 5px; margin-left: 200px;"> <p>Typical example of absent fire stopping to riser cupboard door.</p> </div> <p>Riser cupboards: Remedial fire stopping works are required in the riser cupboards where penetrations made by wires passing through fire resisting walls are found.</p>

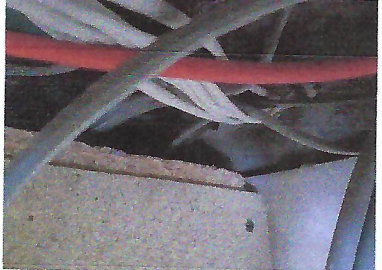
<p><i>(Typical example evident in each cupboard.)</i></p>	<p>5</p> <p>5</p>

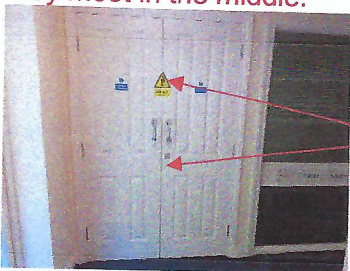
<p>Intumescent strip and cold smoke seal required along this edge.</p> <p><i>(The above requirement was required of Building Regulations as advocated by The Approved Document B at the time of build.)</i></p> <p>Compartmentation/fire stopping planning: It should be confirmed that a fire compartmentation/fire stopping plan has been compiled comprising of:</p> <ul style="list-style-type: none"> • Contractors' fire safety information. • As built 'compartment' plans of the building are provided to any person undertaking building works. • Any person undertaking works that breach compartment lines are requested to provide evidence of the materials they have used to seal the breaches and photographs of any concealed works upon completion of their works. • Great Cliff Dawlish Ltd should include within its leasehold agreements a statement saying: 'All building works will be subject to prior permissions from them and where necessary subject to Building Regulations.' <p>Flats: It is recommended that each flat is thoroughly and (if necessary) invasively inspected at the change of any leasehold/ownership to ensure its compartmentation has not been compromised by any (authorized or unauthorized) works.</p> <p><i>(This fire risk assessment will not necessarily identify all minor fire stopping issues that might exist within the building. If you become aware of other fire stopping issues, or are concerned about the adequacy of fire stopping, you may wish to consider arranging for an invasive survey by a competent specialist.)</i></p> <p><i>(A full investigation of the design of heating, ventilation and air conditioning systems is outside the scope of this fire risk assessment.)</i></p>	<p>5</p> <p>✓</p> <p>1</p> <p>✓</p> <p>Advisory</p>

<p>Remedial works should be carried out to the double riser cupboard doors which should have intumescent strip and cold smoke seal installed where they meet in the middle.</p>
