Report and Register  
for a  
Management Asbestos Survey  
**Great Cliff  
Marine Parade  
Dawlish  
EX7 9EX**

**No asbestos containing materials were identified**

The survey was undertaken on  
**10 May 2021**

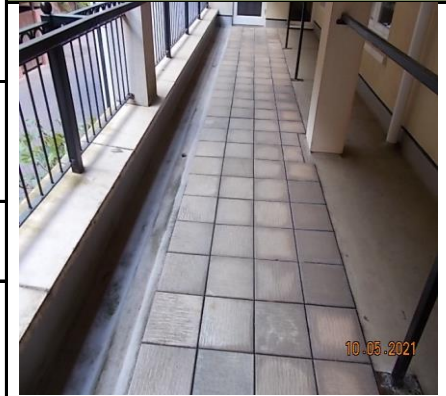
<b>Location</b> External balconies	Dscn0379	<b>Material Reference</b> 1 La
<b>Material description</b> External palisade tiles

<b>Sample number, if sampled</b> N/a		
A look alike material that does not contain asbestos
