REPORT ON LEAKING BALCONIES

AT THE PROPERTY KNOWN AS

Great Cliff
Marine Parade
Dawlish
EX7 9EX

Date of Inspection: 8 January 2019

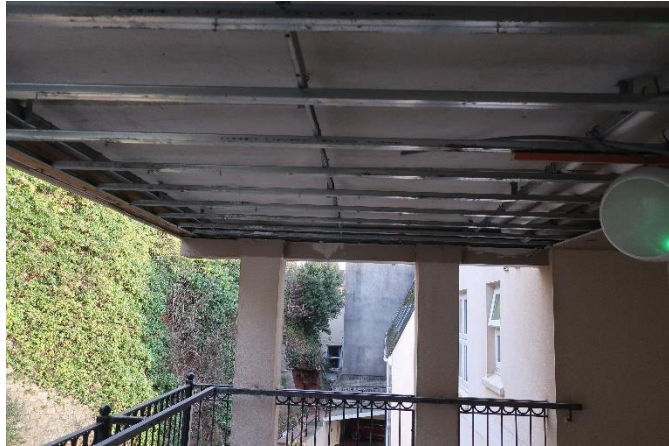
On our inspection, the balcony soffit of Flat 19 which forms the ceiling balcony of Flat 14, had been removed back to the suspended ceiling grid. This ceiling had been removed as we understand the boarding was heavily stained and affected by dampness.

On removal of the ceiling, it can be seen that the steel suspended ceiling grid is starting to corrode in areas, and around the perimeter of the balconies, paintwork is peeling to the wall finishes, the timber infill battens are water stained, and the cladding around the underside of the beam downstand.

It does therefore appear that water has been penetrating down through the perimeter walls, but moisture is also travelling across in various areas of the balcony, affecting the ceiling support grid.

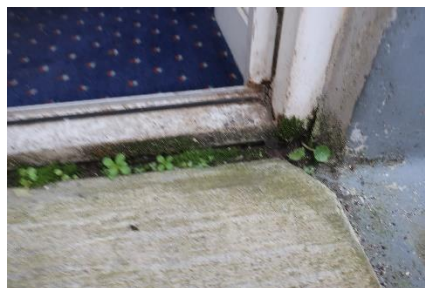
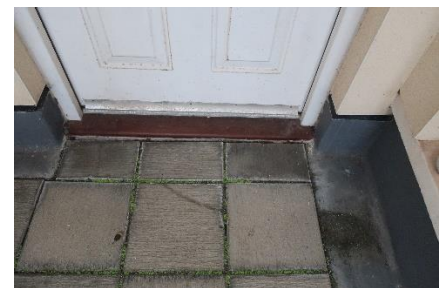
On inspecting the balcony above which serves Flat 19, the balcony is covered with asphalt, with promenade tiles, and the asphalt has been painted with a solar-reflective paint around the upstands.

The detailing of the asphalt is not ideal, in that there is a level threshold to the entrance corridor and the balcony slopes down to the entrance door of Flat 19, having no drain in the lowest area of the balcony and a recessed cill outside Flat 19.

The frame to the entrance door is rotting and water could obviously penetrate through where the asphalt stops underneath the door threshold.

The asphalt is also slightly peeling back, surrounding the soil pipe, and there are isolated open joints under the cill projection to the front wall of Flat 19.

The rotten and level cill detail to the entrance staircase and the level cill in the recessed lowered area outside Flat 19 are clear areas where water can penetrate through the asphalt and ideally, the doors would be replaced with a raised threshold, so a 150mm asphalt upstand can be provided around all areas of the roof.

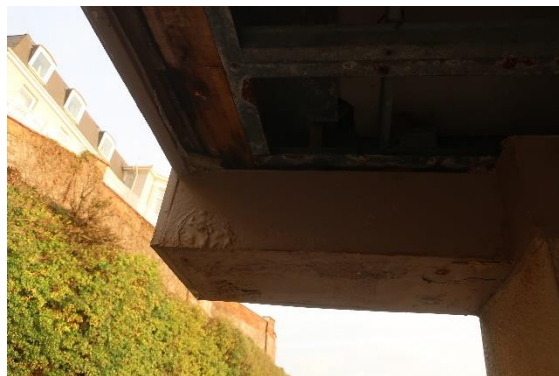
There also appears to be water entering through the side parapet walls of the balcony and this has evidently been occurring for long periods of time, as the galvanised RSJ framework around the edge of the balcony is starting to corrode.

On inspecting the coping stones on top of the wall, there is a minimal overhang on the outside edge of the wall and a coping stone should be provided with a clear drip channel, and a good overhang on each side, which we typically would require 50mm overhang. This clear drip channel and the overhang is provided in order to allow rainwater to drip down to the ground clear and free from the wall beneath.

In addition, there does not appear to be any evidence of a damp-proof course under the coping stone and as the joints in the copings are now starting to open, water can penetrate down through.

We would therefore recommend that the coping stones be lifted, with new wider coping stones being provided, and laid over a continual damp-proof course, in order that there is a 50mm overhang and clear drip channel on each side of the wall, and an impermeable DPC membrane underneath the coping.

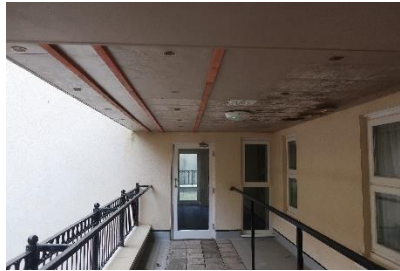
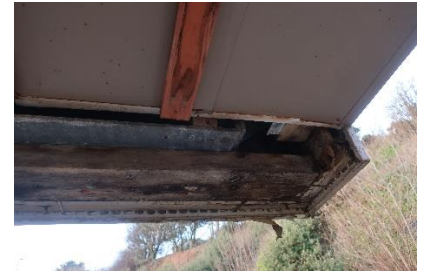
The ceiling of the balcony passage serving Flats 15 and 16 is still in-situ, although it has been fixed in position with timber battens being drilled through the ceiling board and into the framework above.

The external edge cladding has been removed to the outer side of Flat 15, exposing the steelwork, similar to that on the ceiling of Flat 14, and the ceiling board is stained in numerous locations, with heavy staining being apparent to the staircase side and mould growth.

The paint finish to the ceiling board is also starting to blister and peel.

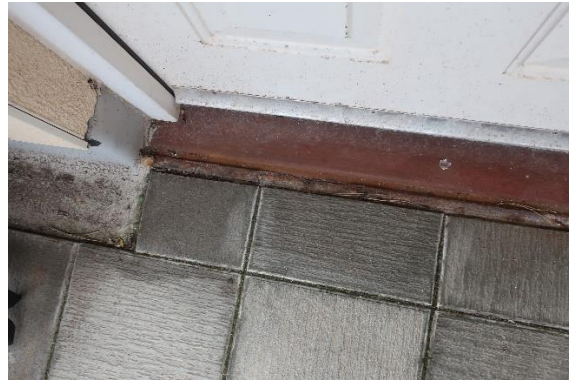
The detailing to the door threshold of the staircase block is, again, poor, having a recessed cill in the asphalt and this does provide an area where water could penetrate through.

In addition, the wall area adjacent the stairway door, the asphalt is starting to pull away and is split in the corner where the stairwell meets the wall of Flat 21, and all these areas require re-sealing, ideally having a lead flashing over.
