FLAT 10 GREAT CLIFF, MARINE PARADE, DAWLISH, DEVON EX7 9EX

In accordance with your recent instructions, we inspected Flat 10 and Flat 15 Great Cliff, Marine Parade, Dawlish in order to provide advice on the potential causes of damp ingress that is entering on the head of the two splayed windows in the living room of Flat 10.

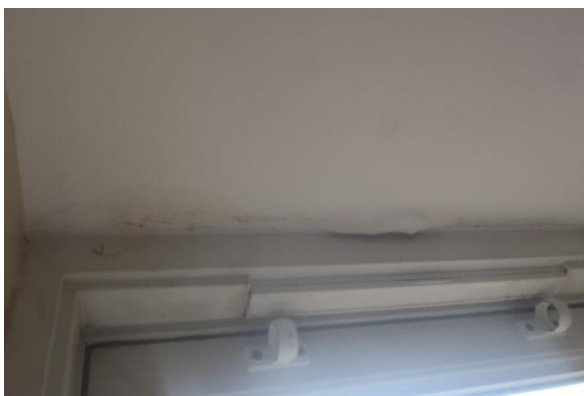
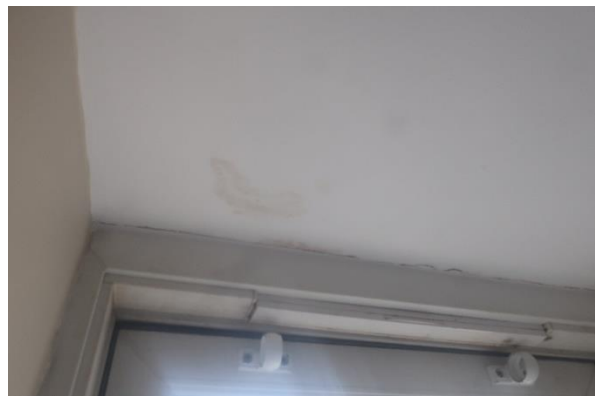
On inspection within Flat 10, to the head of the living room window, where the plasterboard window head meets the window unit itself on both splayed reveals, there is evidence of peeling of ceiling paper and discolouration due to damp ingress.

To the left-hand splayed reveal when looking out, paint blistering also extends down the left-hand reveal of the window which, again, is lined in plasterboard.

We tested the window areas using an electronic damp meter and damp readings of up to 99% were noted to the two window heads, reducing to circa 60% on the window reveal. The plasterboard sheet to the areas which were tested is also relatively soft, suggesting it is starting to break down slightly as a result of water ingress.

As there will be a cost of scaffold for investigatory works in any case, we would recommend that provision be made for cutting out and replacement of the cavity trays on all faces of the bay window so that new proprietary cavity trays with fixed stop-ends and interlocking corners can be installed, together with sufficient weep vents to let the water weep out.

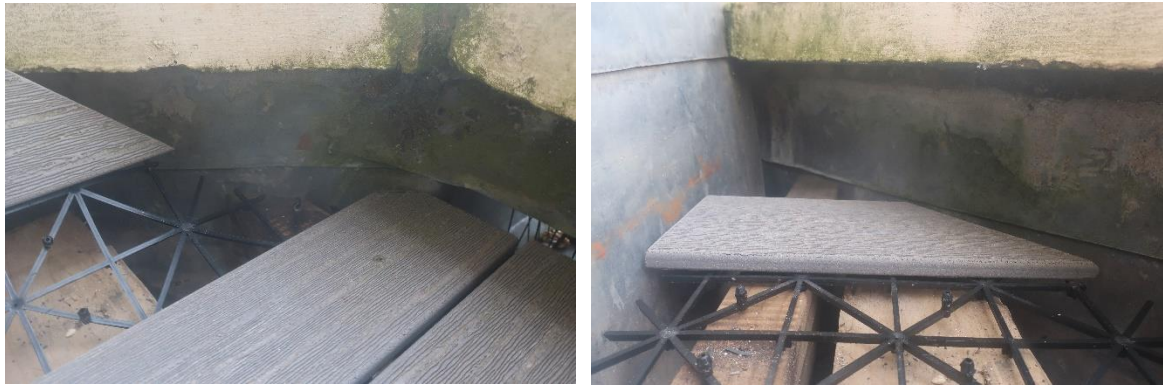
We were able to inspect the front balcony over this bay window within Flat 15 and the balcony is overlaid with a composite decking board which is sat in a proprietary matting system. We could lift a small area of this deck to the side corner of the wall, and it appears that this bay window is formed with a lead sheet roof covering.

Whilst we could not lift all the decking to fully inspect the lead sheet roof, in the areas exposed it was not defective, plus the dampness noted in the ceiling of the wall below is positioned further out within the thickness of the wall itself, as opposed to directly beneath this bay roof.

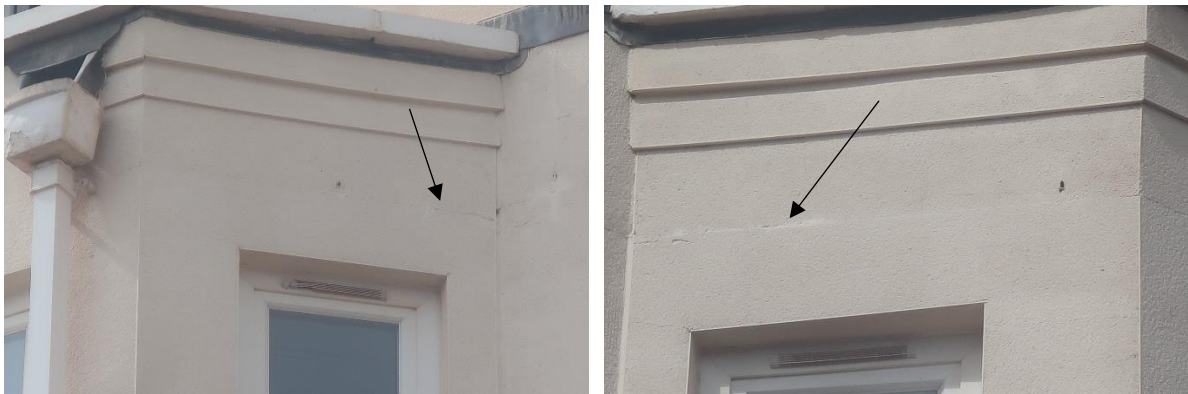
There is evidence of scarring on the outside of the wall through the K-rend finish which run horizontally just above window level, and this would typically be where a lintel or cavity is provided, and there are also some areas where the walls appear to have been filled in, possibly where weep holes have been fitted.

With most weep holes now no longer being present, there is a possibility that the cavity trays are filling up and overflowing, especially if they are not proprietary trays with corner upstands, as buildings of this age typically had sheets of polymer DPC used to act as the tray.

With water entering just inside the positioning of the window, it does appear that there may be a problem associated with the cavity trays, although the only method to confirm this would be to cut into the wall and expose the tray. This will obviously require scaffolding or a MEWP.

The use of a Beak weep vent would be preferable in this location due to the high winds experienced.

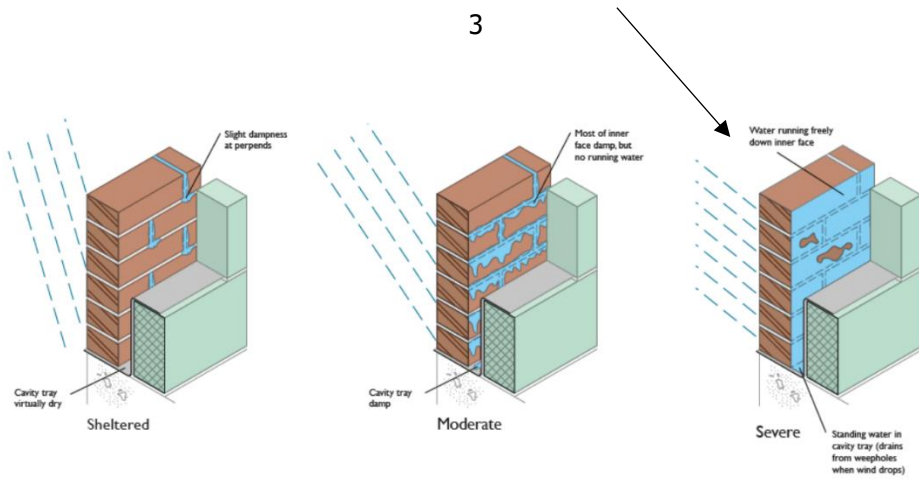
The property is located in an extremely severe location and water will enter the cavities, as shown on the image beneath.
