DAMP INSPECTION REPORT

On:
Flats 20 & 23 Great Cliff
Marine Parade
DAWLISH
EX7 9EX

30 January 2023

Croft Surveyors Ltd
No. 3 Little Priory Offices
Fore Street
Totnes
Devon
TQ9 5NJ

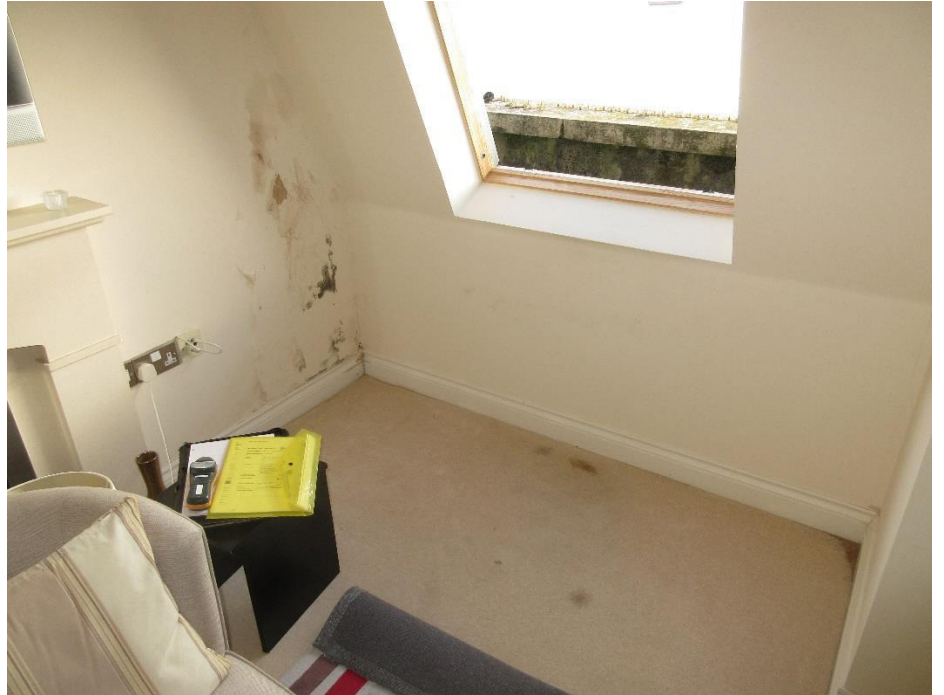
The flank walls to either side of Flat 20 are suffering from penetrating damp causing staining and deterioration in internal plasterboard dry-lining at their junctions with the front wall of the mansard roof. This is causing significant damage to plasterwork finishes, especially to the northern party wall.

The moisture detected at higher level indicates it is likely to be stemming from a defect in weatherproofing to the short parapets rising above the slate-covered roof slopes.

In addition, the concrete floor of Flat 20 is very wet, at its junction with the front wall of the mansard alongside the northern party wall in the sitting room. This is causing staining and deterioration in the carpets and skirting boards.

Fig.1 Damp damage in Flat 20

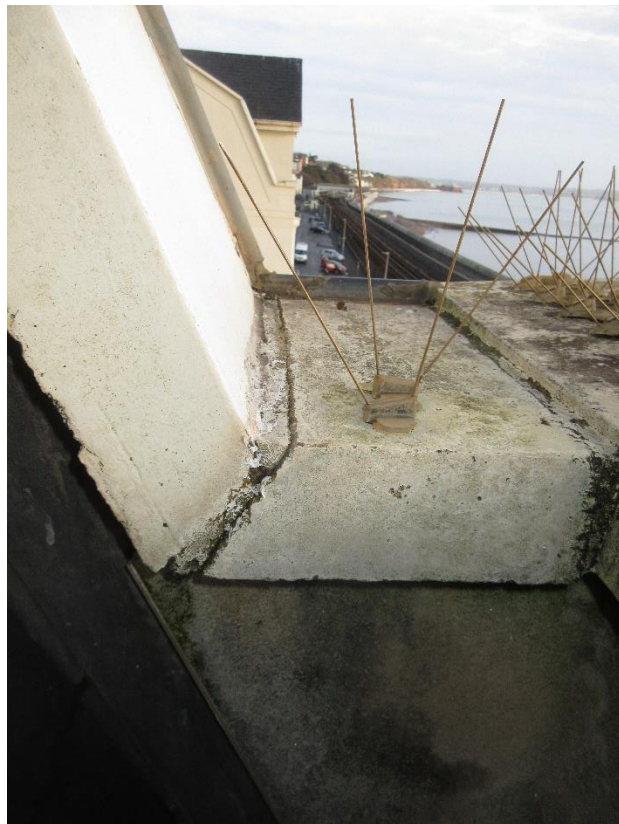
The coping stones to the parapets have some open cracks in their mortar-pointed joints which will allow a little water to penetrate. There should be a damp proof course (DPC) beneath the coping stones, to protect against absorbed rainwater from soaking down through the masonry to affect internal walling, although without removing the coping stones this can't be verified.

Attempts have been made to improve weatherproofing including silicone sealant smeared across joints and an odd metal or PVC upstand fixed to the outside edge of the coping stone over the worst affected northern party wall to Flat 20.

The manner in which the damp has presented following a particularly wet winter tends to suggest that it is caused by saturation of the masonry, as a result of deficient moisture protection externally.

Conjecturally, it is possible that the grey plastic or metal upstand that has been added to the parapet coping over Flat 20 is actually trapping wind-driven rainwater, exacerbating the problem.

Fig.2 Parapet copings stones have cracks in joints into which water can penetrate, possibly exacerbated by the metal or PVC trim added.

To address it requires proper investigation requiring scaffold access. The affected coping stones would ideally need removing and new damp proof courses installing beneath. Another possibly simpler option might be to instead cap all the parapet copings in traditional welted lead-sheet, which is guaranteed weathertight, and lasts many decades.

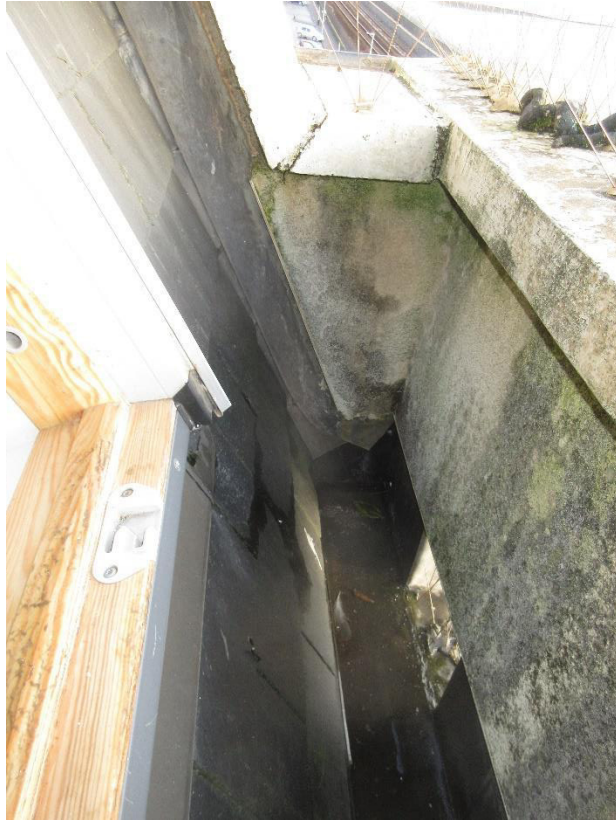
The box gutter behind the front parapet to the northern side of Flat 20 is lined in a black single-ply PVC membrane. We noted that this was partially collapsed, causing it to hold water, and the soft and 'squidgy' feel to the base of the gutter suggests that supporting timber layboards have decayed and failed.

Fig.3 Parapet box-gutter lining appears to be partially collapsed and leaking, saturating the concrete floor of the flat.

The damp affecting the floor of Flat 20 appears to be instead caused by a leak in the single-ply membrane lining to the parapet box gutter immediately in front. This will need stripping out and re-lining, along with replacing the decayed timber supporting lay-boards beneath. This will again require scaffold access and should therefore be combined with the recommended works to the parapet copings.
