### **FLAT 23 GREAT CLIFF, MARINE PARADE, DAWLISH, DEVON EX7 9EX**

Further to your recent instructions, we inspected the main bedroom of Flat 23 Great Cliff on the 30<sup>th</sup> January 2024 in order to provide advice on the potential causes of mould growth, which is appearing on the internal face of the rear elevation wall.

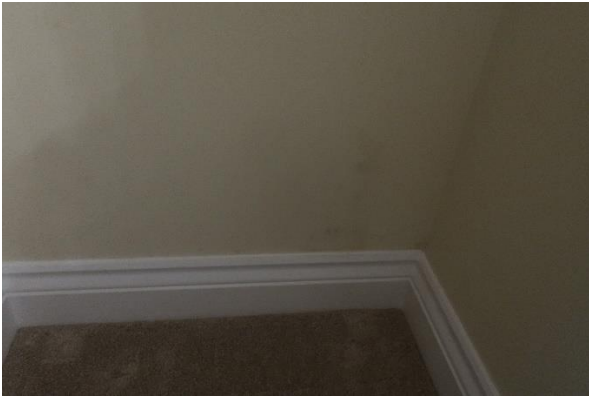
The problem relates to an alcove on the rear elevation wall, and also to the lower wall levels within a fitted wardrobe, which is positioned adjacent.

In these areas, black spot mould is starting to appear at the lower levels of the wall.

*Rear wall alcove*

Within this room, it is only two small sections of wall which are affected, and therefore a cost effective method of reducing the risk of a dew point temperature occurring would be to upgrade the insulation provision to these sections of the wall.

This could be achieved by replacing the current dry lining with an insulation-backed plasterboard, with the insulation being of a thickness so that interstitial condensation does not occur. The actual thickness would need to be determined by the technical team who manufactures the insulation product.

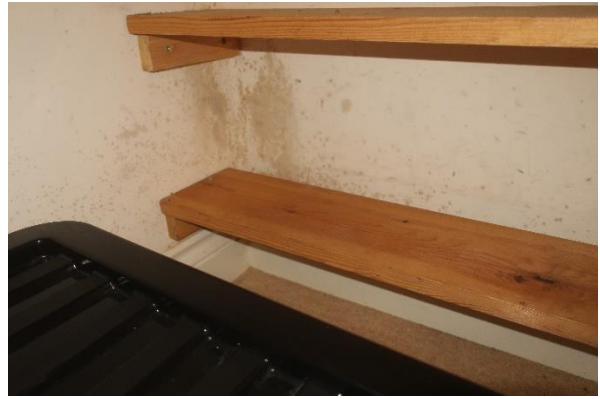
*Rear wall of fitted wardrobe*

The lack of air changes within a fitted wardrobe and in an alcove behind furniture, will also have an impact on the level of condensation occurring.

Installing the insulation would require some adaptation to the wardrobe area, and the removal and replacement of the skirtings and the like.

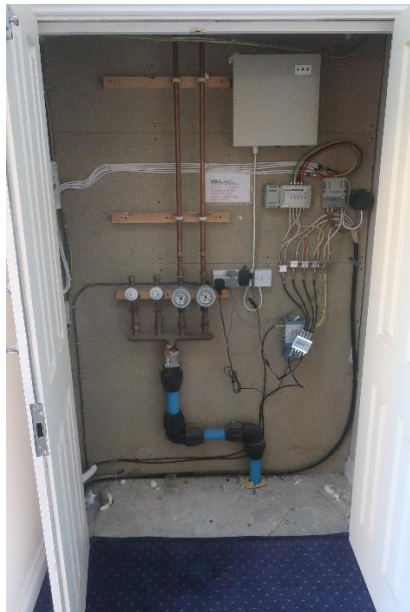
On inspecting areas of the property around the affected areas, the parts of the wall that were affected meet the back wall of a services cupboard from the communal area, which is an unconditioned area, having a concrete block wall between. There does appear to be a void behind the back wall of the services cupboard, as the wall thickness from calculation is over 500mm.

*Back of services cupboard*

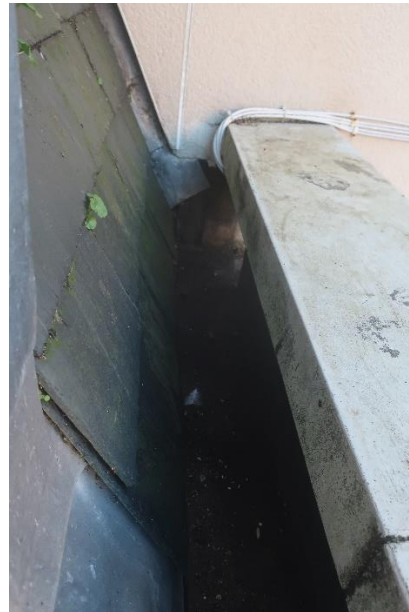
*Box gutter adjacent flank wall*

The main rear wall of the bedroom is formed by the rear slope of the mansard roof, and this is provided with a box gutter forming the drainage channel of the roof. The box gutter does terminate on the side return wall, where the rear wall meets the flank wall of the stairwell, and we understand that this box gutter does block with leaves and debris and requires clearing regularly. It is essential that box gutters of this nature are regularly cleaned, as they will overflow down the wall if left to block, although it is not believed that this box gutter is attributable to the mould growth appearing in the fitted wardrobe, or the back wall.

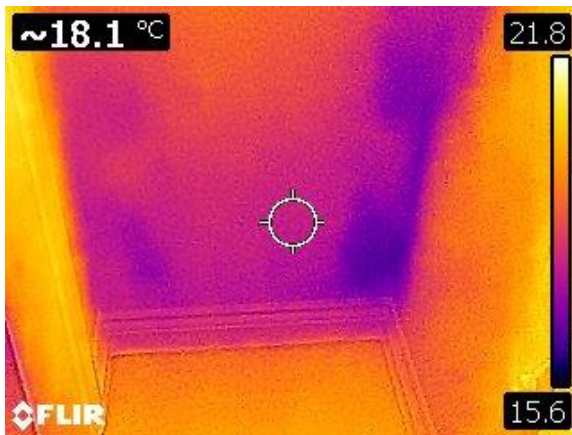
When inspecting using the thermal imaging camera, it does show darker areas on the wall where the mould is appearing. These dark areas would indicate colder spots on the wall finish, and by carrying out a simple tap test, it appears that the cold areas are located in areas where a dot and dab adhesive

has been applied. These types of adhesives are typically applied quite heavily around the corners of wall areas to make a rigid finish to the wall.

*Thermal image of rear alcove*

The installation of a dot and dab adhesive therefore breaches any gap between the plasterboard and the wall behind, and that wall behind will be a cold element as it meets the staircase.

Where the heated internal flat meeting the colder elements, cold bridging will occur, and this seems to be occurring on the areas where the dot and dab adhesive is positioned to secure the plasterboard. The cold bridging is likely therefore causing the mould to grow as a result of condensation.

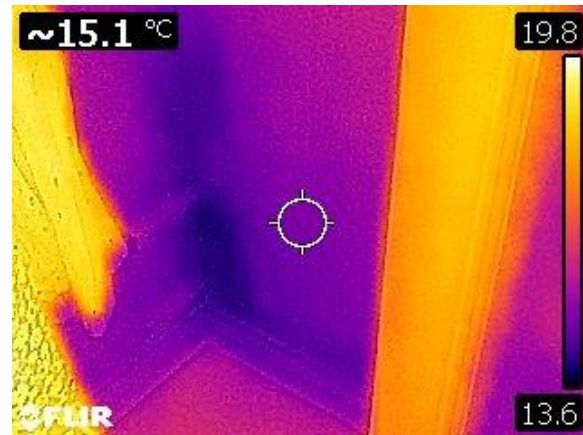
*Thermal image of wardrobe*
