Report Document – No. 52874

PROJECT NAME: Great Cliff- Dawlish

Roof Survey Report & Recommendations

Roof area covered by this report: Roof 01, Roof 02, Roof 03

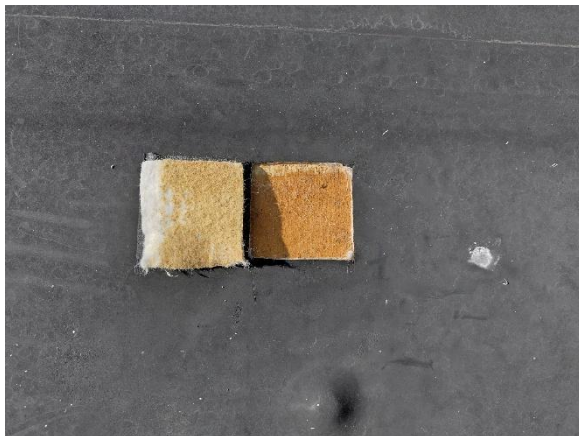
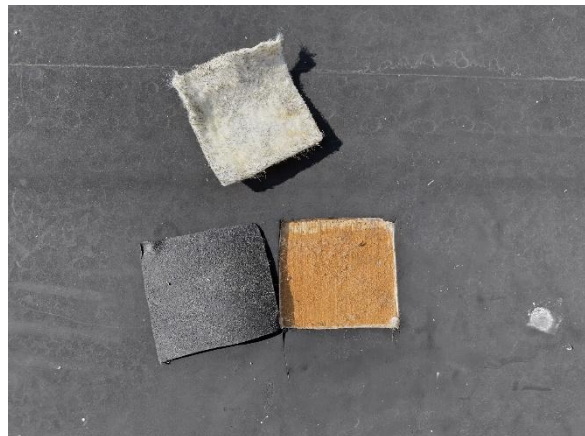
ID	Feature	Condition	Thickness
1	Deck - Plywood	Dry	18 mm
	Waterproofing - EPDM	N/A	N/A

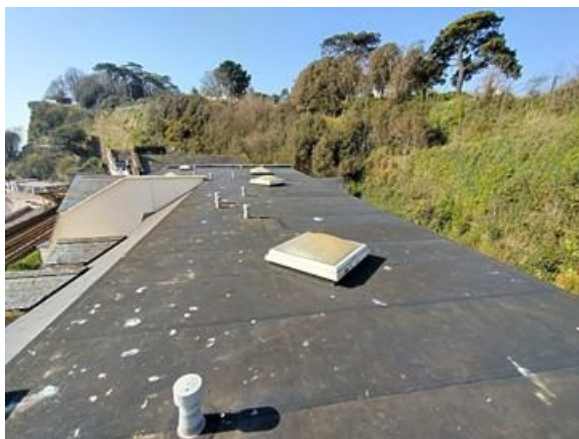
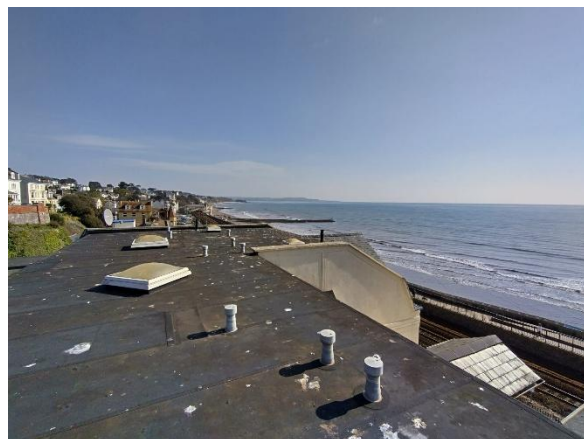
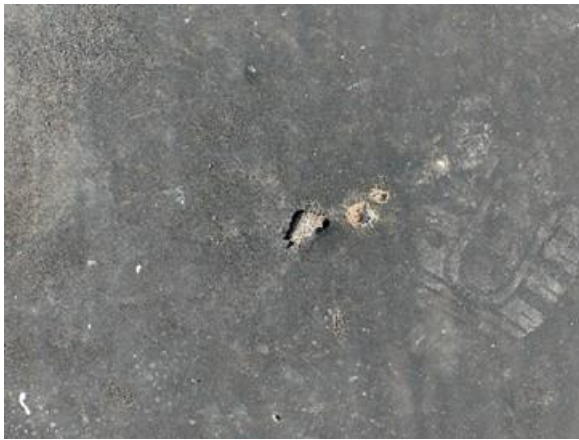
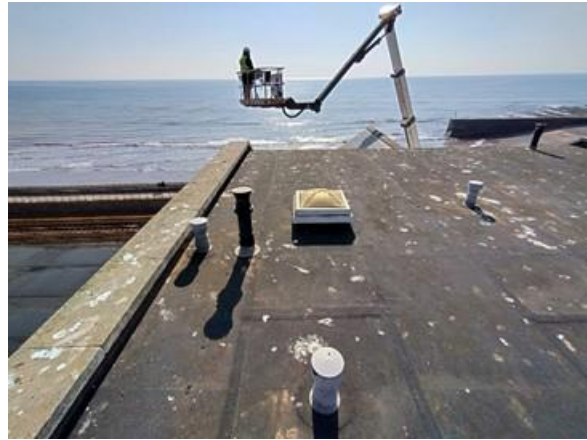
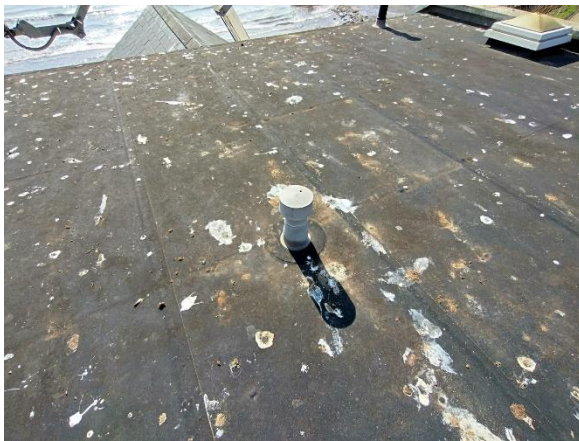
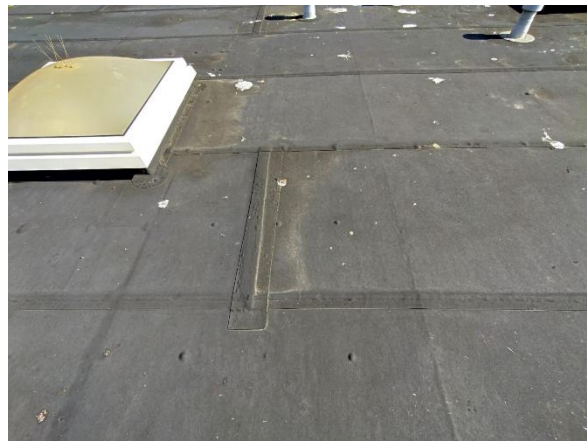
- The roof surface appears to be in a poor condition.

- This roof is the main roof area of the building. The high points appear to be in the centre, with falls directing water towards both the front and rear of the building, where it drains via the mansard slate roof and exits through the external gutters. There are parapet walls at both ends of the building, capped with coping stones. The waterproofing assembly comprises of a plywood deck overlaid with a rubber/EPDM membrane. The field area includes sixteen vents, and there is a total of eight rooflights- four large and four small.

- Blisters within the existing waterproofing system strongly suggest that there may be design issues relating to interstitial condensation. Another possible explanation is that water vapour was trapped during construction, or water has found its way into the roof system during the service life of the roof.

- The presence of organic material and staining may indicate that the roof has not been draining as designed. The accumulation of organic matter can obstruct the flow of water to the gutters, leading to ponding, which accelerates membrane wear and increases the risk of leaks, particularly at seams or penetrations. If the organic matter is not removed, the service life of the roof is likely to be reduced.

- Bird droppings (Guano) present a risk to health and should be removed by a specialist. Rotting organic matter is likely to adversely affect the service life of the roof due to the high acid content that can weaken adhesives and slowly degrade the membrane if left in place.

- There is physical damage to the existing roof waterproofing system, there is a hole in the EPDM leaving the timber substrate open to the elements. It is highly likely that rainwater will ingress into the roof system or building.

- Localised repairs have been made using an EPDM membrane. Repairs to this area suggest an on-going or historical issue at this location.

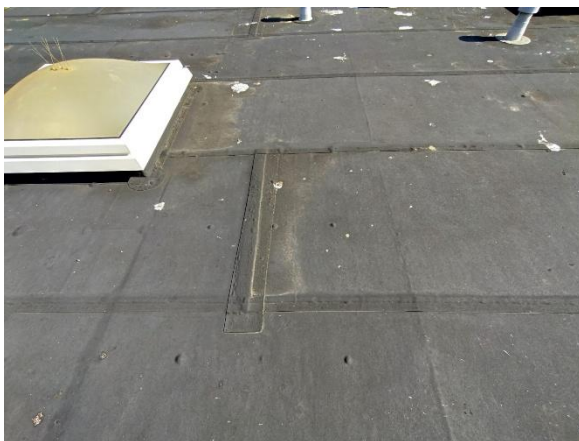
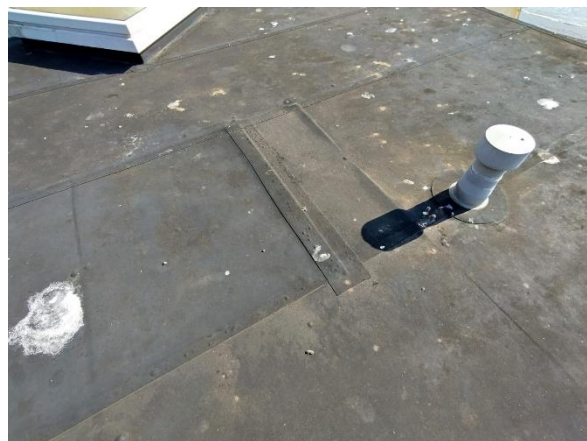
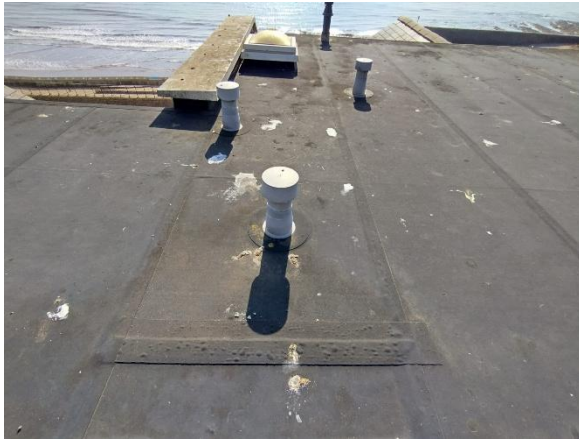
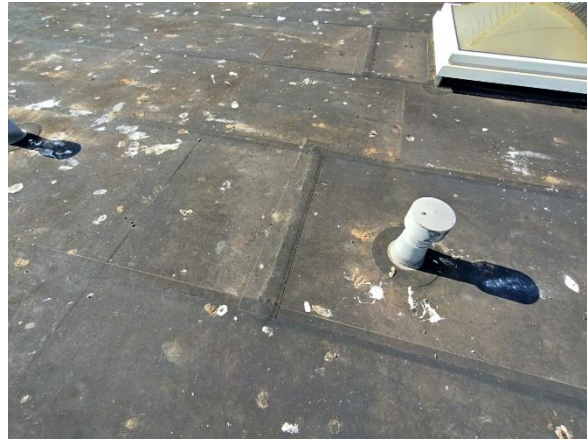
Repairs

Upon inspection, we identified that localised repairs have been undertaken using an EPDM membrane. Patch repairs suggest a historical issue at this location and patch repairs can create an uneven surface that traps water, leading to ponding and further damage to the membrane.

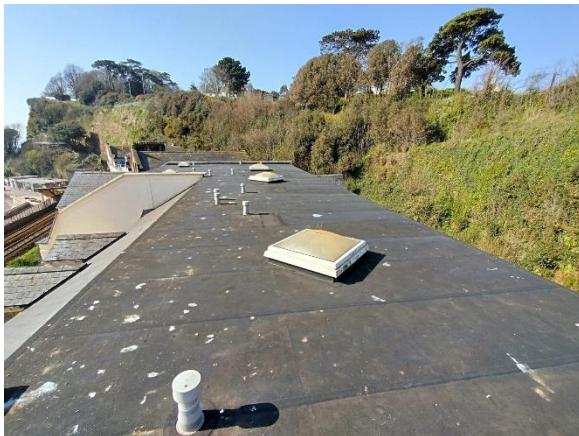
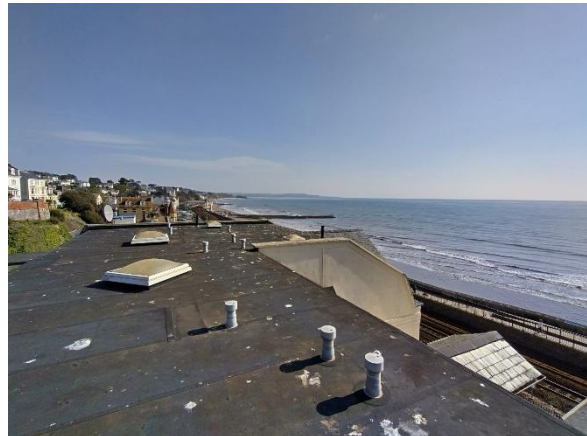
Standing Water: No areas of ponding (standing water) were identified during our survey.

Comment: All available evidence at the time of our survey suggests that the roof slope (fall) complies with the current standards BS 6229:2018.

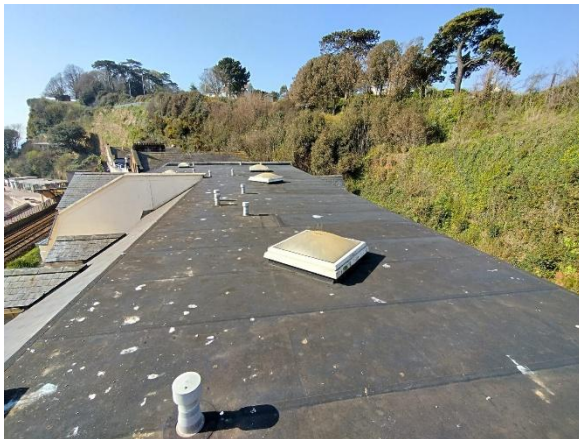
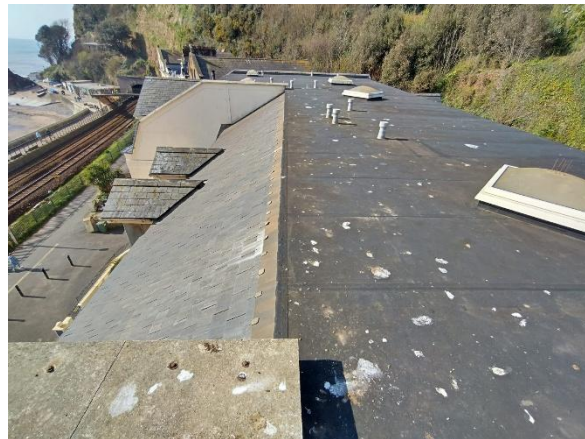
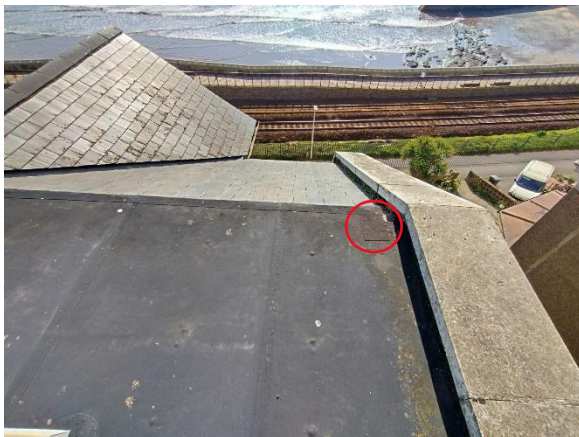
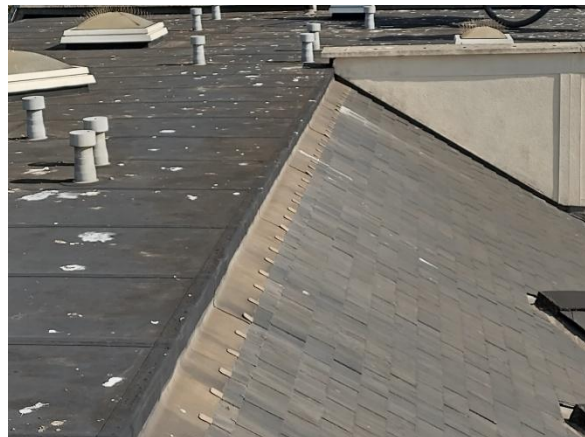
Subject: Draining edge without an external gutter

Comment: The draining edge is located at the front and rear of the building, where water drains via the mansard roof. The draining edge appears to be in poor condition. The circled area highlights a patch repair to this detail, which suggests a previous issue with water ingress. The presence of living organic material and staining may indicate that water is not being removed as intended. All organic matter should be cleared to prevent further drainage issues and potential damage to the roofing system.

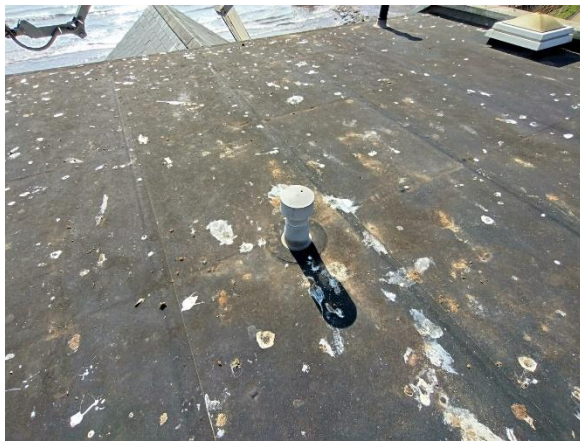
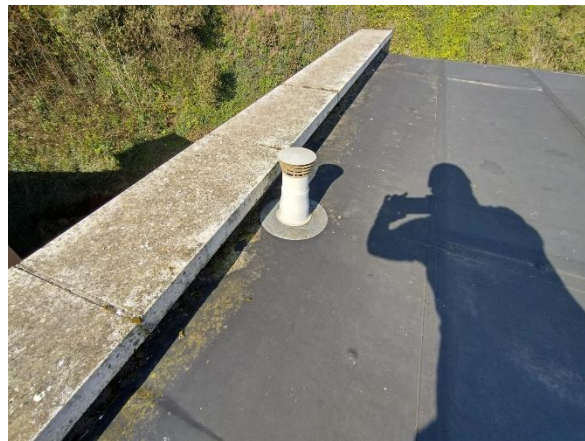
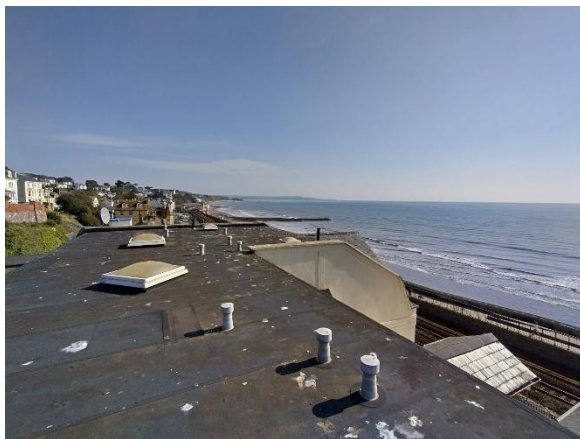
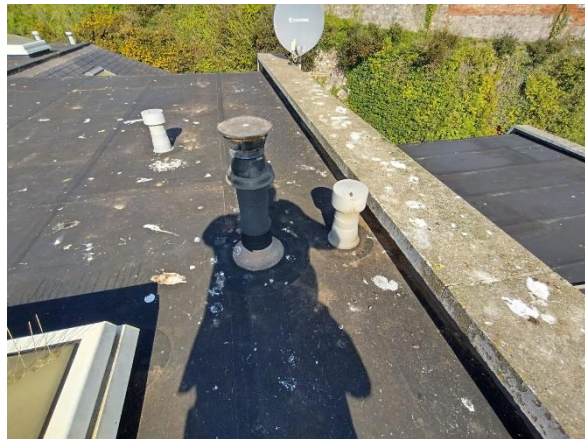
Detail: Roof Vent

Condition: Poor

Comment: There are sixteen roof vents in this area. The detailing around these vents appears to be in average condition; however, all sixteen vents are missing the required jubilee clips. To prevent exposure to environmental elements, it is essential that each vent is fitted with a weatherproofing collar securely fastened with a jubilee clip. This configuration ensures a watertight seal and helps maintain the structural integrity of the roofing system. Additionally, there is evidence of staining, organic material, and guano present. If not removed, these contaminants are likely to reduce the service life of the roof.

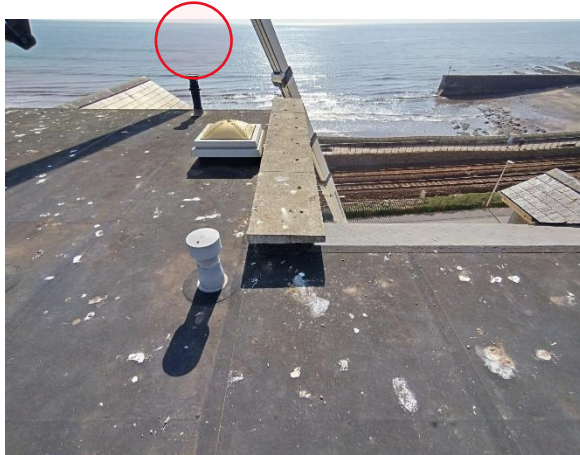
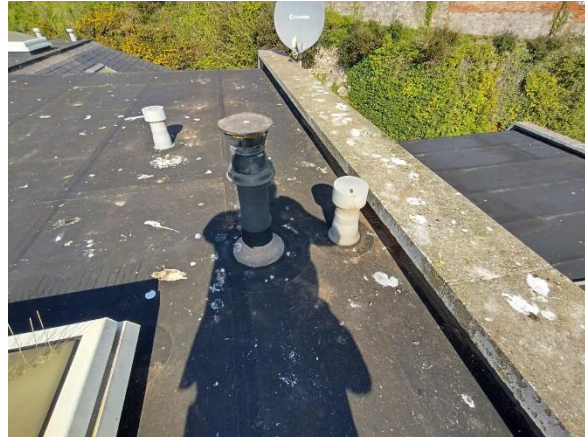
Detail: Boiler Flue (suspected)

Condition: Average

Comment: There are four suspected boiler flues on this roof area, two each end of the building. These flues are beginning to show rust/corrosion. Rust weakens the integrity of the metal, creating

potential gaps or holes. If not addressed the boiler flue would be more vulnerable to damage from weather, wind, or water ingress.

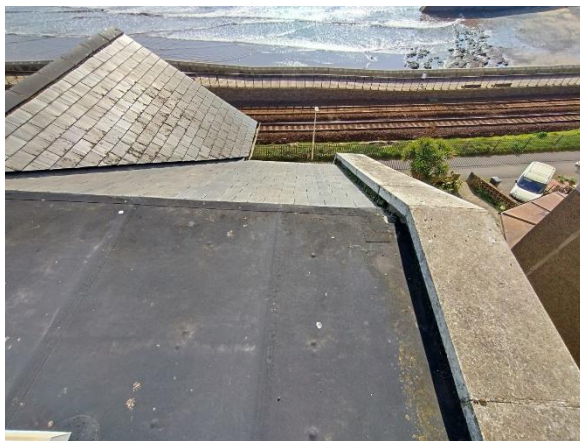
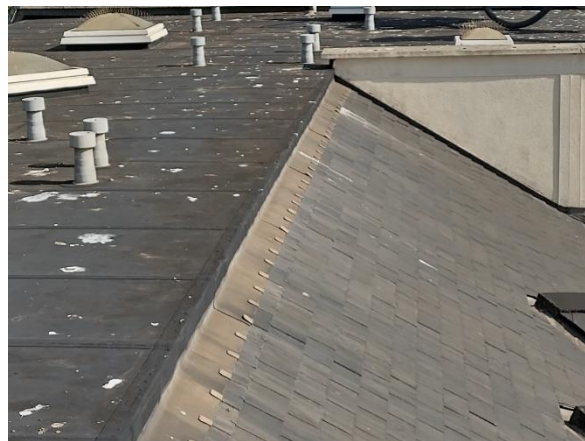
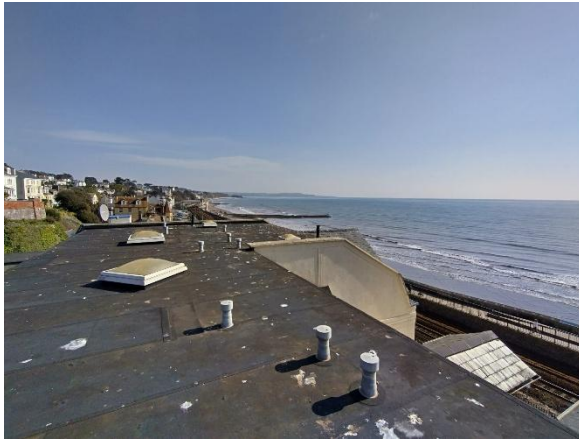
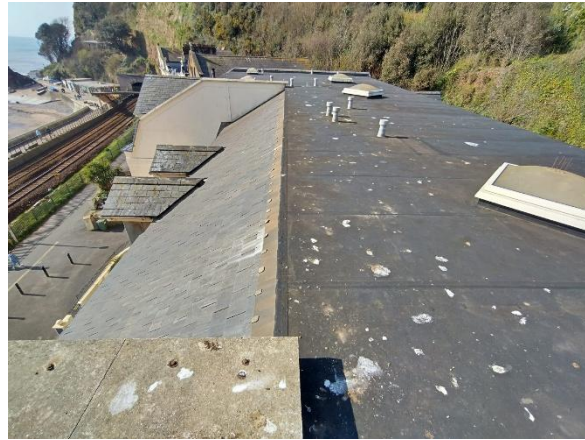
Detail: Mansard edge

Condition: Average

Comment: The mansard edge runs the length of the front and the rear of the roof area. The lead to this detail appears to be in average condition. The growth of moss, algae, or lichen on the lead or can hold moisture against the materials, promoting corrosion of the lead. Regular cleaning of the lead is essential to prevent biological growth that could cause long-term damage. A patch repair using EPDM membrane has been used on the waterproofing of this detail. This could suggest there have been water ingress issues in this area.

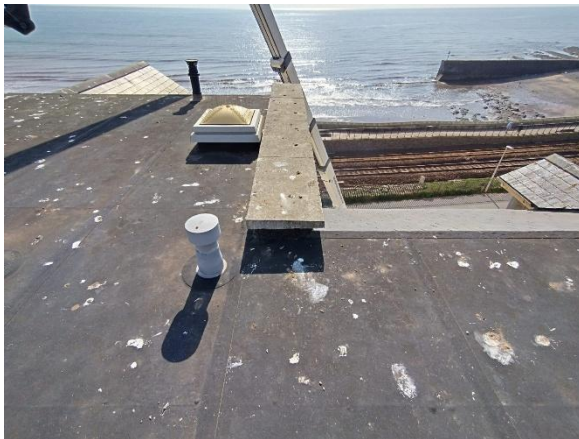
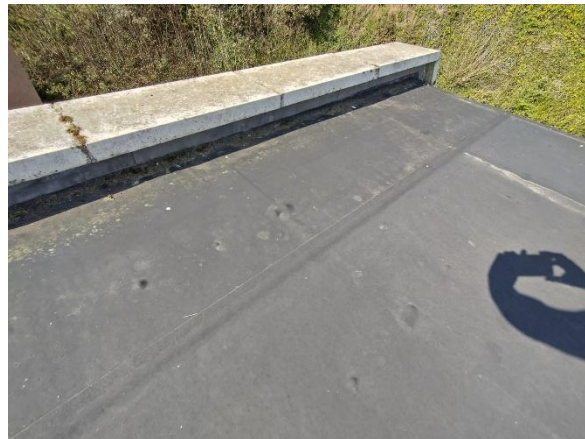
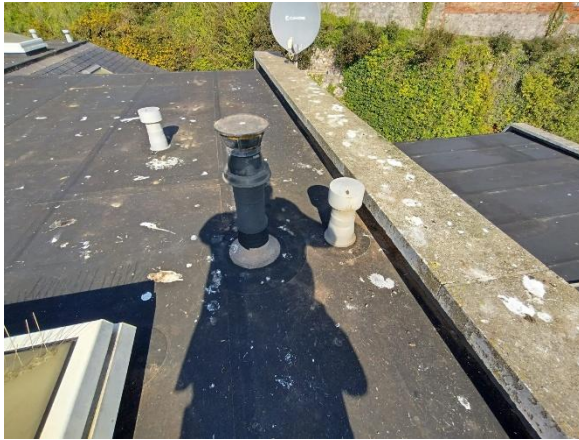
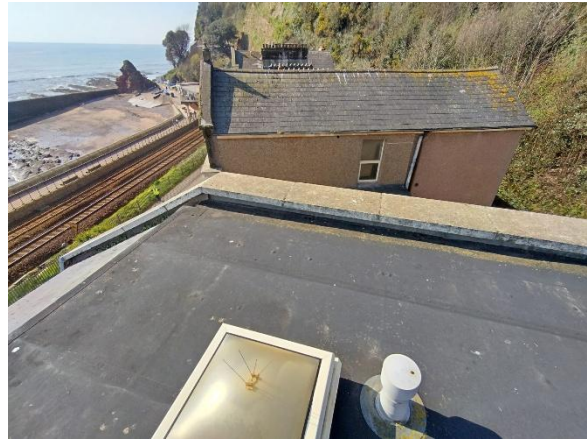
Detail: Parapet kerb with coping stone

Condition: Average

Comment: The parapet kerbs are located each end of the building, one on each perimeter and a little detail situated alongside the mansard roof. Organic material/Lichen is present on both the abutment and the coping stones to this detail. Unless removed Lichen accelerated the degradation of the mortar joints by penetrating the surface, and the moisture retained in the moss undergoes freeze-thaw cycles which further compromises the integrity of the waterproofing. The parapet detail currently sits below the 150mm upstand height required by BSS6229:2018. This will need to be raised to achieve 150mm above the finished surface level with the introduction of insulation.

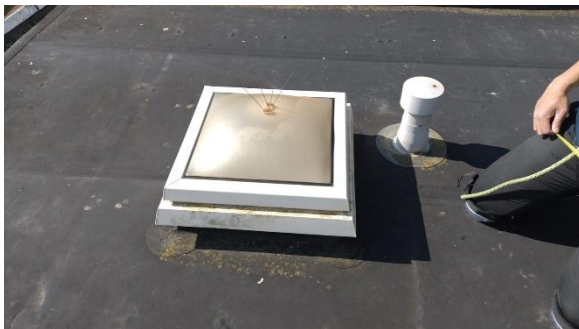
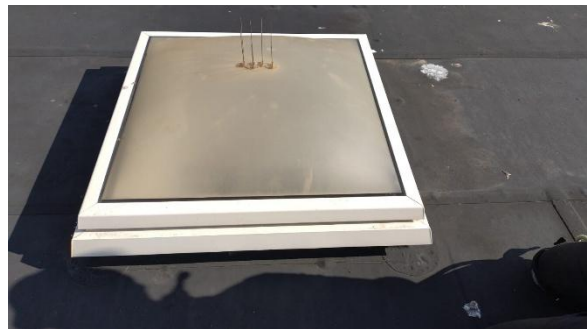
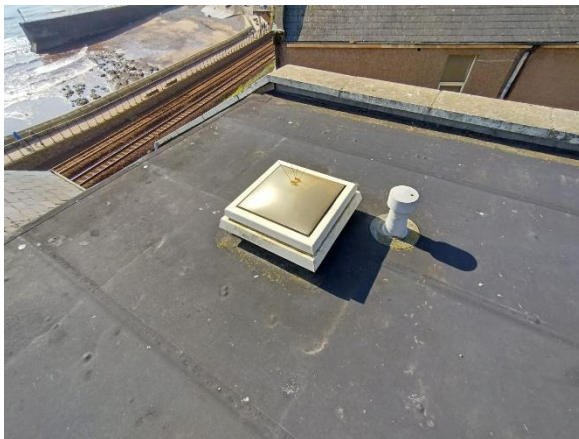
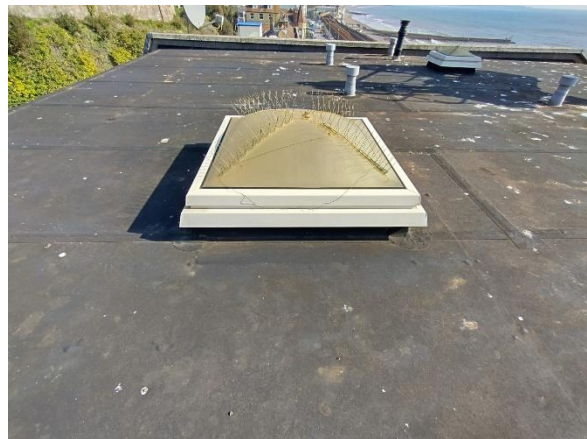
Subject: Polycarbonate

Condition: The rooflight is in a poor condition.

Comment: There are eight rooflights in this roof area. All eight units provide poor light transmission into the building and the glazing has been damaged by the effects of UV radiation, leading to discolouration of the unit. These may need to be replaced to ensure internal light levels are maintained.

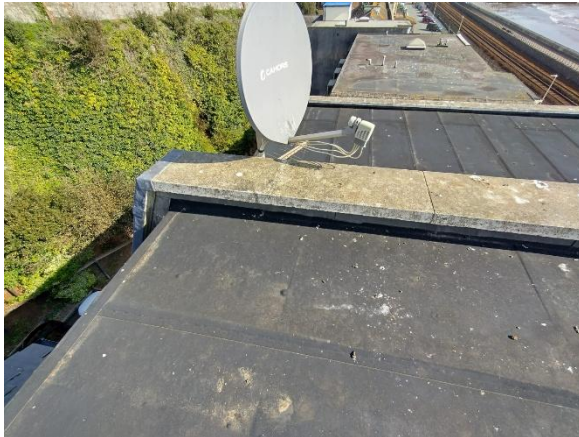
Subject: TV ariels

Comment: There is one aerial located on the parapet wall neighbouring Roof 02. The aerial appears to be in average condition and should be temporarily decommissioned during the works. It can be reinstated upon completion, if required.

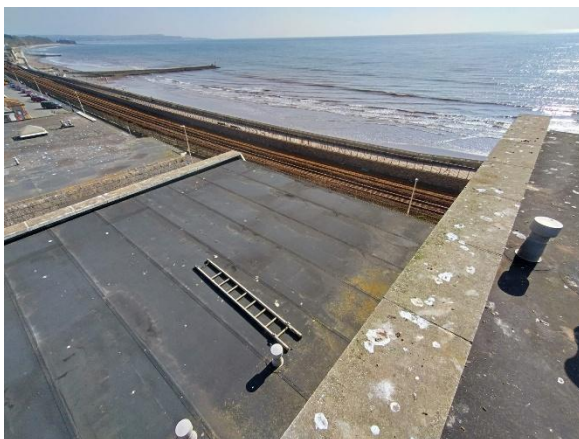
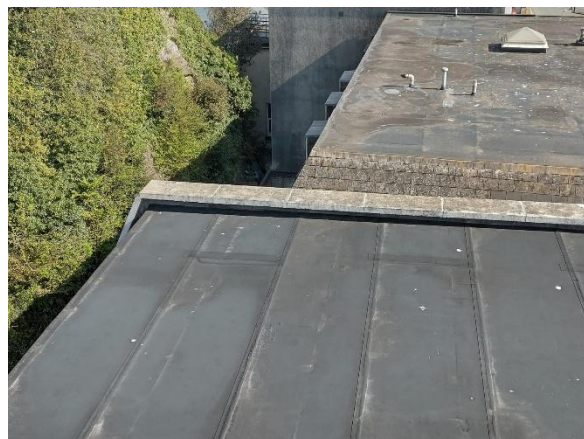
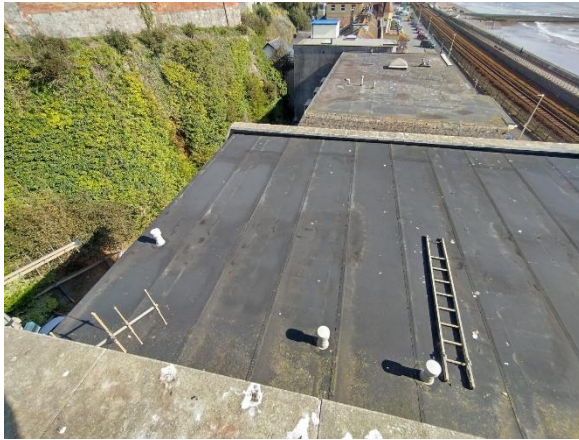
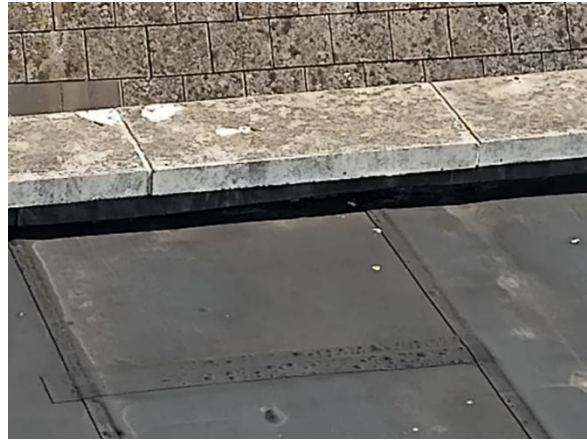
- The roof surface appears to be in a poor condition.

- This roof area is a lower roof, situated next to roof 01 and abutting the main building. Like roof 01 this roof consists of an EPDM waterproofing and a parapet wall with coping stones run the perimeter edge. The high point appears to be central with the falls directing rainwater towards the mansard slate roof and draining through the external guttering.

- The lap/joint of the membrane is beginning to show signs of deterioration, a condition that is expected to worsen over time.
- Blistering observed within the EPDM waterproofing system may be down to several factors. Common causes include interstitial condensation due to poor design or insufficient ventilation, the entrapment of moisture during installation, or water ingress occurring over the roof's service life. Additional contributing factors may include poor adhesion between layers, and the use of incompatible materials or adhesives. Blisters can compromise the long-term performance of the roof by weakening the membrane's bond to the substrate, making it more susceptible to wind uplift and mechanical damage. Over time, they may also allow further moisture ingress, leading to deterioration of the underlying structure.

- Organic materials and staining are present throughout this roof area. Moss accelerates the degradation of the waterproofing coverings by penetrating the surface and the moisture retained in the moss undergoes freeze-thaw cycles which further compromises the integrity of the waterproofing.

- Bird droppings (Guano) present a risk to health and should be removed by a specialist. If not removed, guano is likely to adversely affect the service life of the roof due to the high acid content.

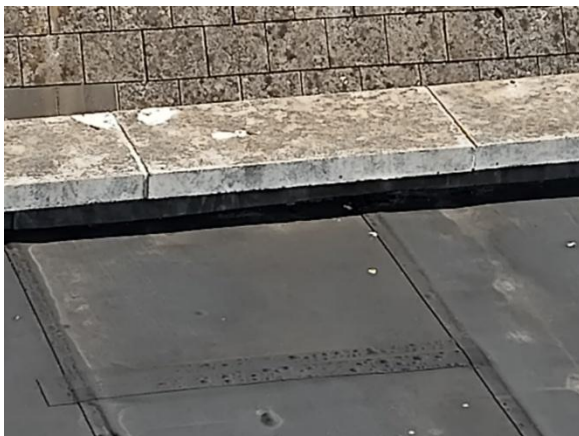
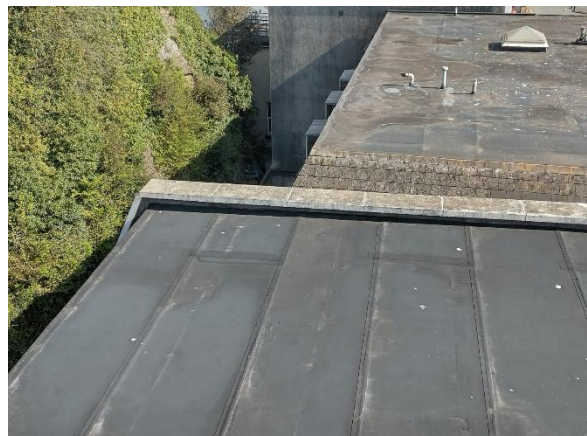
Repairs

There is evidence that localised repairs have been undertaken using an EPDM membrane on the seam/lap of the waterproofing. Multiple repairs suggest an ongoing or historical issue with the roof at this location.

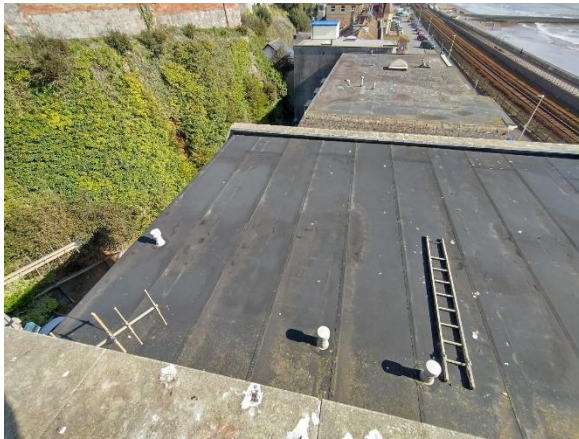
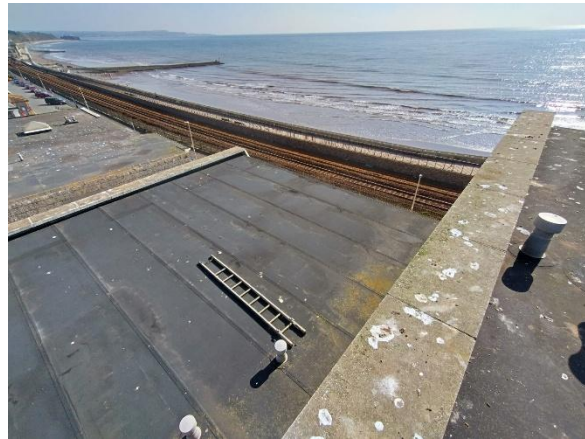
Standing Water: No areas of ponding (standing water) were identified during our survey.

Comment: Like roof 01, the high points appear to be in the centre, with falls directing water towards both the front and rear of the building, where it drains via the mansard slate. All available evidence at the time of our survey suggests that the roof slope (fall) complies with the current standards BS 6229:2018

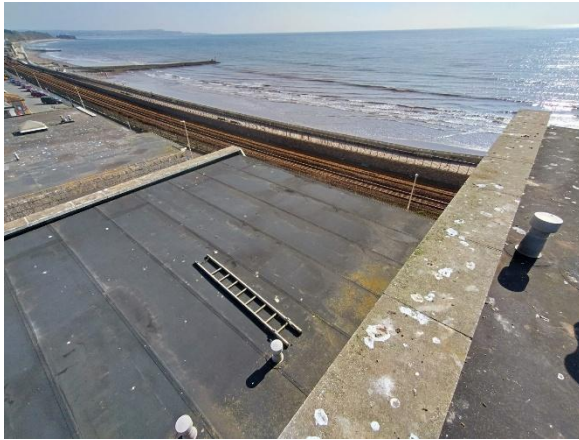
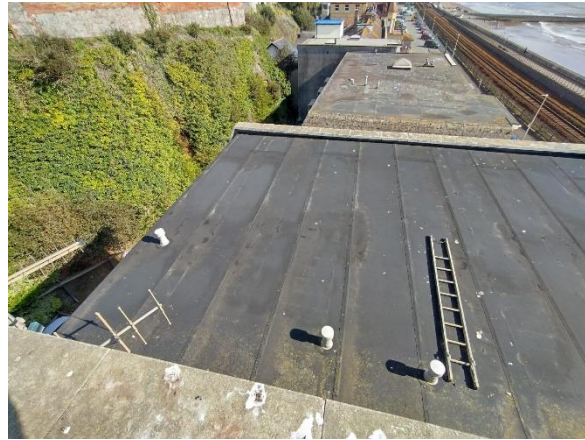
Detail: Roof vents

Condition: Average

Comment: There are three roof vents in this area. The waterproofing membrane detailing these vents appears to be in average condition. However, all vents are missing jubilee clips. To prevent exposure to environmental elements, it is essential that each vent is fitted with a weatherproofing collar, securely fastened with a jubilee clip. This configuration ensures a watertight seal and helps maintain the structural integrity of the roofing system. There is evidence of staining, organic material, and guano present. If not removed, these contaminants are likely to reduce the service life of the vent details.

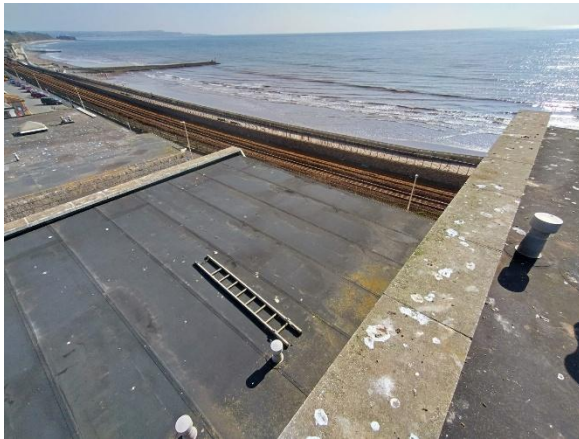
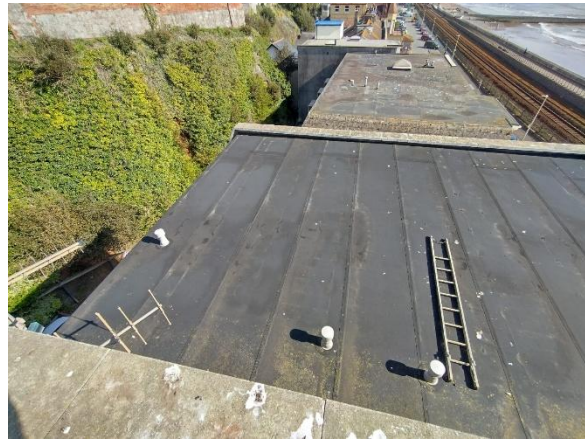
Detail: Mansard edge

Condition: Average

Comment: Due to access, we were unable to determine the full condition of this detail. A visual inspection was carried out from roof 01 which would suggest the mansard edge is in an average condition. Organic material is present, and staining is visible to the waterproofing membrane. Further clarification will be required to determine the condition of the lead flashing prior to works commencing.

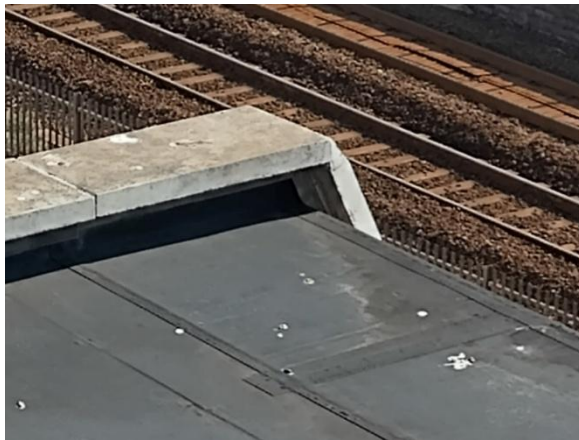
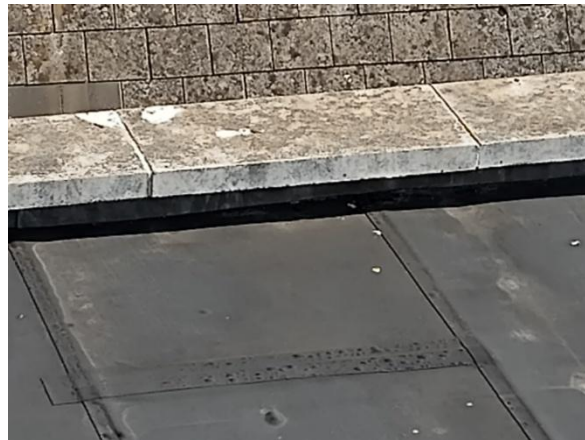
Detail: Parapet kerb with coping stone

Condition: Average

Comment: The parapet kerb is located on the perimeter edge of roof 02. Although this detail appears to be in an average condition, organic material/Lichen is present on the coping stones to this detail. Unless removed, Lichen accelerated the degradation of the mortar joints by penetrating the surface, and the moisture retained in the moss undergoes freeze-thaw cycles which further compromises the integrity of the waterproofing. The parapet detail currently sits below the 150mm upstand height required by BSS6229:2018. This will need to be raised to achieve 150mm above the finished surface level with the introduction of insulation.

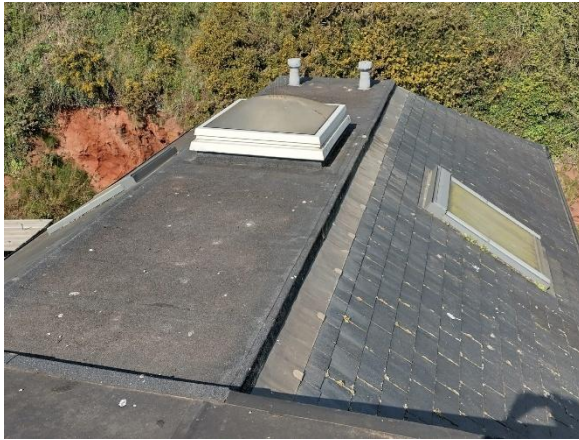
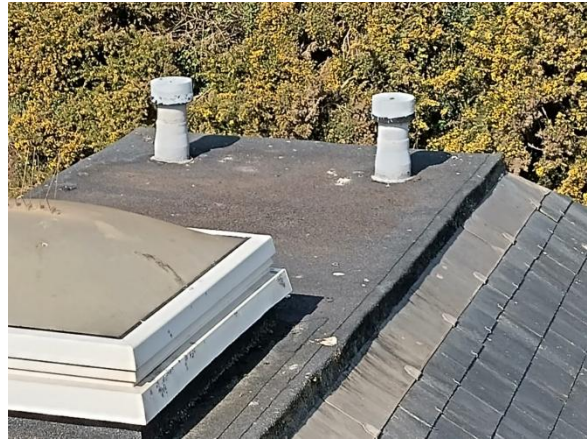
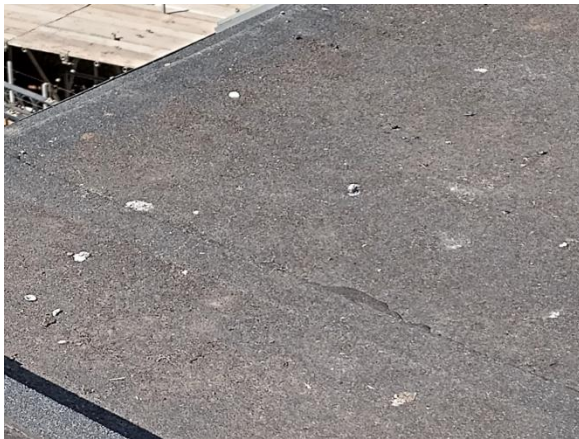
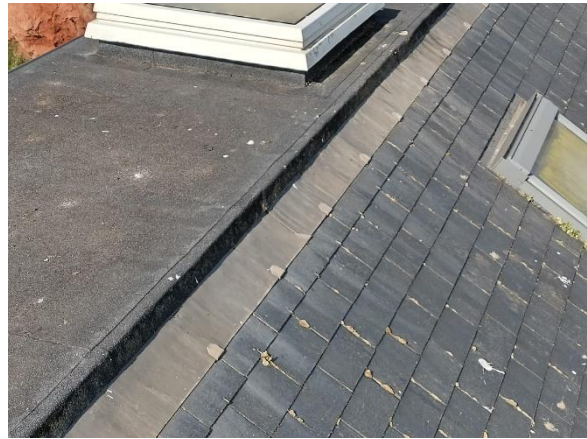
- The roof surface appears to be in a poor condition.

- This roof area abuts the main building of roof 01. Unlike the other roof areas on site, this roof area's waterproofing covering is a mineral finished bituminous membrane. Drainage is via the drip edge leading to the mansard slate roof and into the external gutter. There is an abutment detail/change in level where roof 01 steps down to meet this roof area. There are two roof vents and one window on this roof space.

- The Bituminous membrane coverings appear tired and Mineral chippings that once protected the membrane have worn away and displaced due to wind, rain and UV exposure, indicating that the waterproofing qualities of the membrane has reached the end of its life.

- Surface crazing is a strong indicator that the roof waterproofing system is reaching the end of its service life. These effects are typically a material-related issue that suggest reduced flexibility. Crazing is likely to become more widespread over time.

- The lap/joint is beginning to show signs of deterioration. Failed joints can allow water to infiltrate, especially where roof membranes and other materials contract or expand due to temperature changes. This can result in water damage and structural issues.

recommend that this roof is stripped back to its deck and overlayed using a new TA25 warm roof system, incorporating Parafoam insulation.

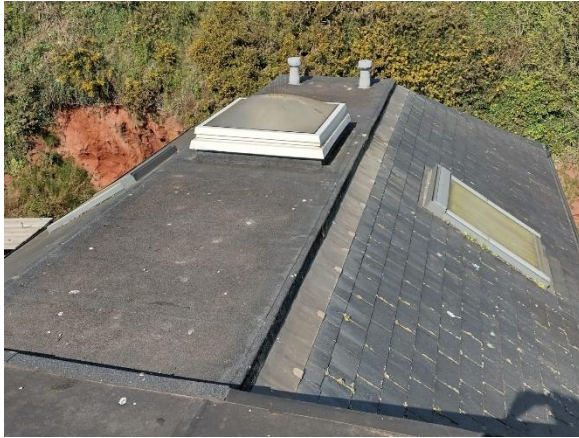
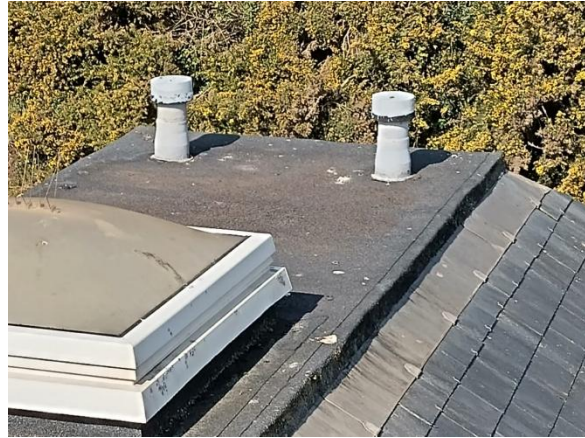
Standing Water: No areas of ponding (standing water) were identified during our survey.

Comment: All available evidence at the time of our survey suggests that the roof slope (fall) complies with the current standards BS 6229:2018

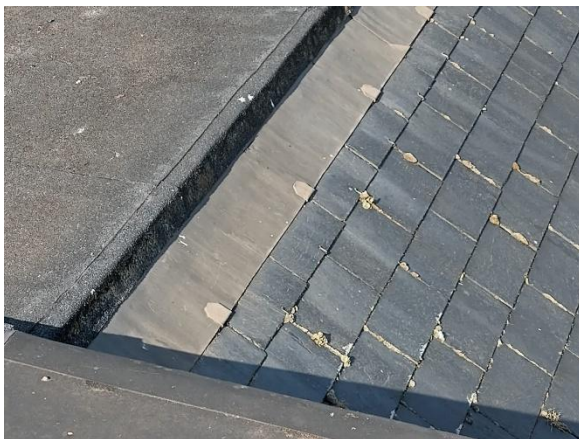
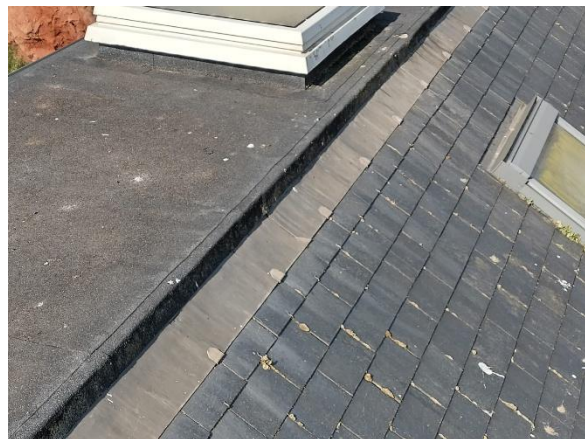
Detail: Mansard edge

Condition: Poor

Comment: The mansard edge runs the full perimeter of roof 03. Age and summer temperatures have caused the bitumen to stain and ripple towards the low point of this drip detail. As the bitumen migrates it has a detrimental effect on the integrity of the cap sheet. Over time, this is likely to worsen, leaving the waterproofing system compromised. The lead flashing to the slate pitched roof appears to be in an average condition.

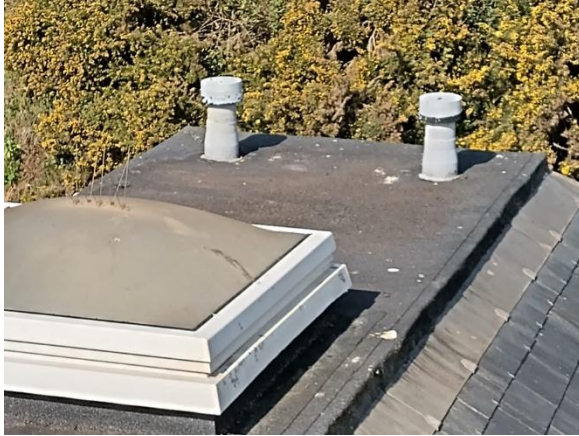
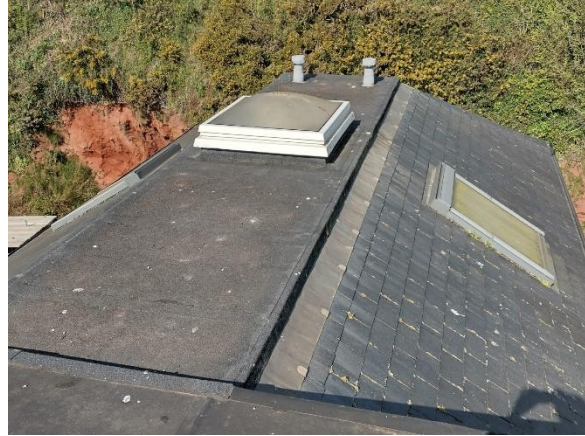
Detail: Roof vent

Condition: Average

Comment: There are two roof vents to this area. Both vents appear to be in an average condition but are lacking the jubilee clip required to keep the capping cowl watertight.

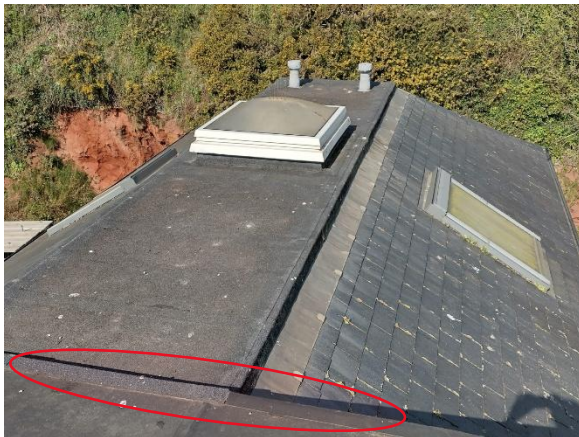
Detail: Changing level

Comment: We were unable to determine the condition of the change in level. Further clarification will be required to determine the condition of this detail, but this change in level would have to be considered during the works.

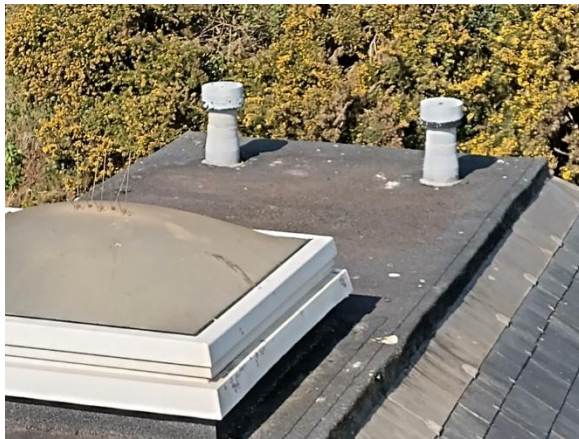
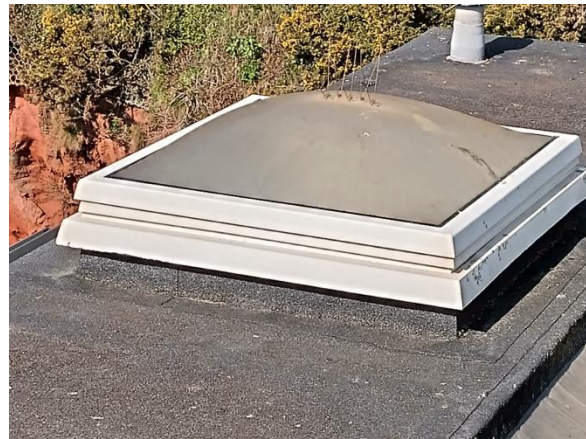
Subject: Polycarbonate

Condition: The rooflight is in a poor condition.

Comment: There is one rooflight on roof 03. The glazing has been damaged/discoloured by the effects of UV radiation and may need to be replaced to ensure internal light levels are maintained. This rooflight will have to be raised with the introduction of insulation to meet the requirements of BS 6229:2018. A roof upstand must extend a minimum of 150mm above the finished surface of the roof system.
