**FLAT 16 GREAT CLIFF, MARINE PARADE, DAWLISH, DEVON EX7 9EX**

Further to your recent instructions, we inspected Flat 16 Great Cliff, Marine Parade, Dawlish on 9 May 2025 in order to advise on the potential causes of water ingress entering above the patio doors on the front of the living room.

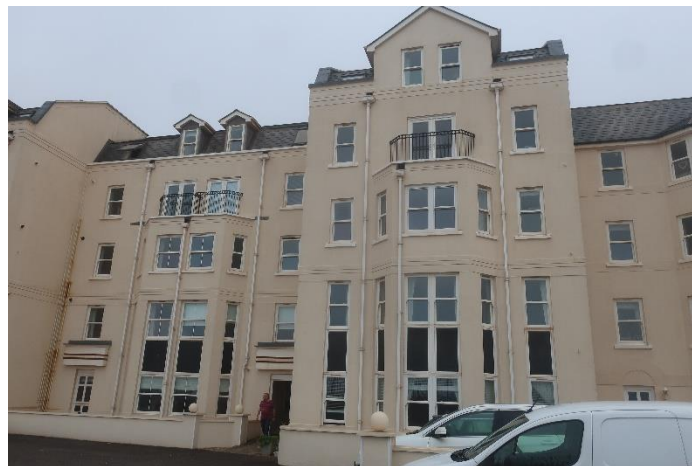
Great Cliff is a modern purpose-built block of flats built over five levels and located adjacent the seafront in Dawlish.

It is built in a traditional construction, having rendered masonry cavity walls under a pitched slate covered main roof.

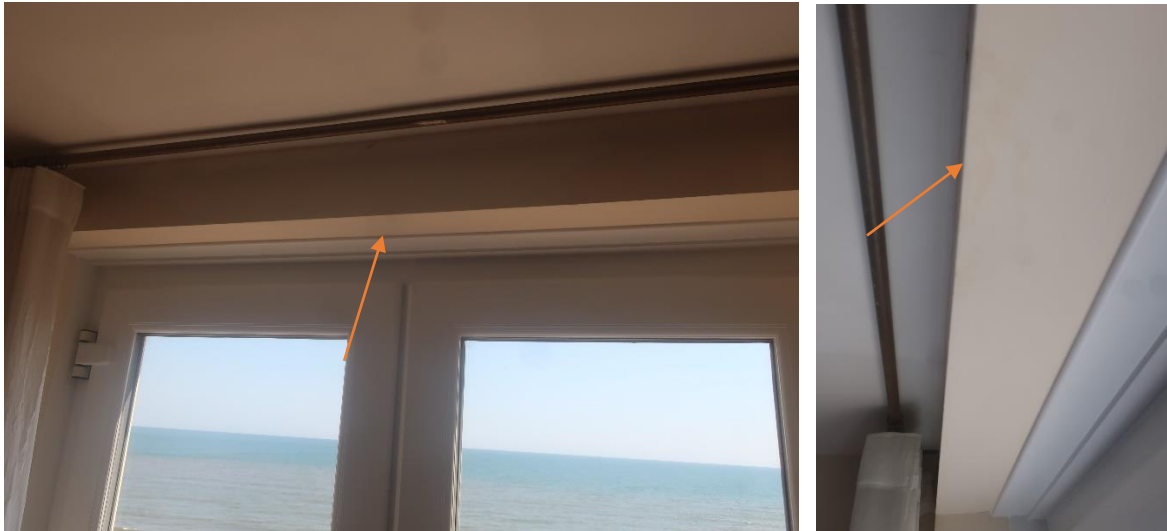
The issue relates to the centre of the patio door head within the living room, on the sea-facing elevation of the property.

On inspection, there is a small area of paint that has peeled and I was shown copies of photos indicating damp staining.

On discussion with the owners, water ingress does occur rarely, with the last incident being December 2024, and it appears to only occur during times of specific directional wind-driven rainfall.

On testing the area during our inspection with an electronic damp meter, no high damp meter readings were noted.

We did inspect after a period of dry weather, and the front wall is dry-lined with plasterboard, leaving a small void between the masonry and the wall lining itself which will of course mask any evidence of water ingress.

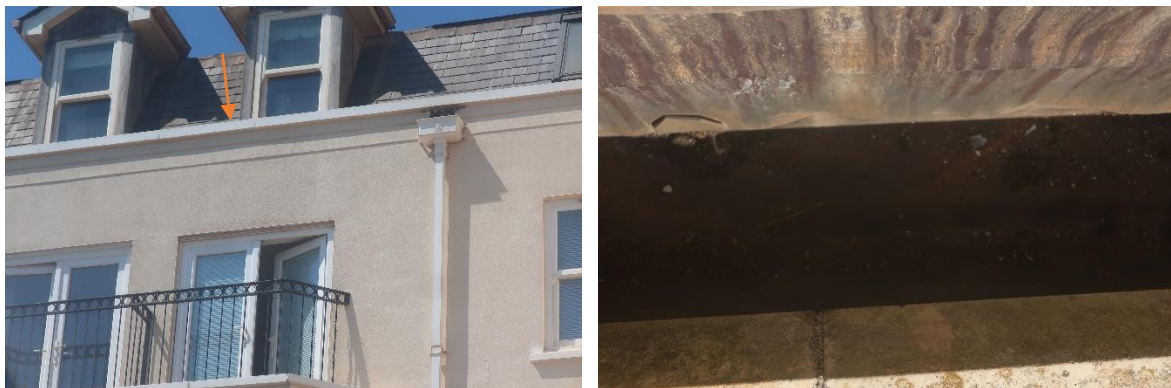
On viewing the area directly above the door in the flat above, immediately above the patio doors, there is a box gutter lined in what would appear to be EPDM membrane, and this dresses up and over a front parapet wall. This parapet has a concrete coping on.

We are aware of previous leaks occurring in similar locations on this property, and water ingress could be entering either from a failed EPDM membrane lining the box gutter, or down from the slated roof mansard, weeping in behind the EPDM membrane as it laps up the roof slope.

EPDM membranes can suffer from minor penetrations which are not visible to the eye, and these breaches can only be confirmed with electrolysis testing, therefore, testing is likely to be required, together with some exploratory works at roof level.

Unfortunately, due to height restrictions, and the fact that our inspection was limited from viewing outside of the windows of the flat 25 only, scaffold is required to closely inspect.

At this stage therefore, we cannot confirm the precise cause of the water ingress as access is problematic. Scaffold is therefore required with some exploratory works being undertaken in the box gutters, and to the roof pitch adjacent the roof level dormer windows.
