FLATS 3, 11, 12, 13, 16 AND 20 GREAT CLIFF, MARINE PARADE, DAWLISH, DEVON EX7 9EX

Further to instructions being received via Crown Property Management, we inspected various flats at the above development which are experiencing problems in relation to water ingress.

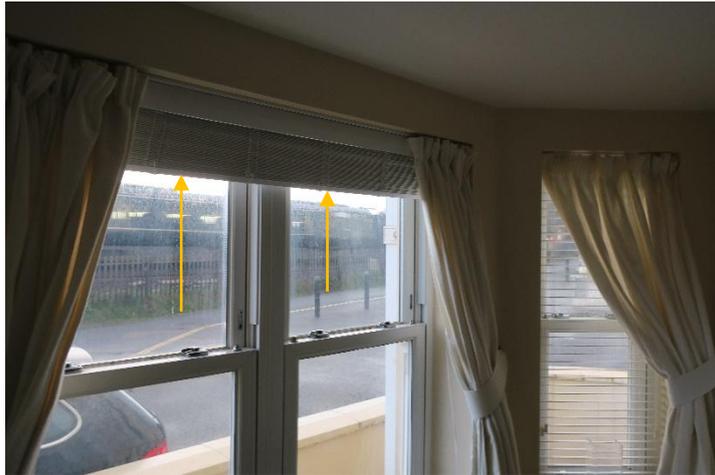
Flat 3 is provided on the ground-floor of the property and the area affected is the front bay window, where water drips through the head of the window into a bucket. We understand from speaking to the lessee that the water ingress only occurs during strong wind-driven directional rain conditions, although the paintwork on side reveals of the window are starting to peel, so the water ingress does appear to be travelling around the head of the window down the sides.

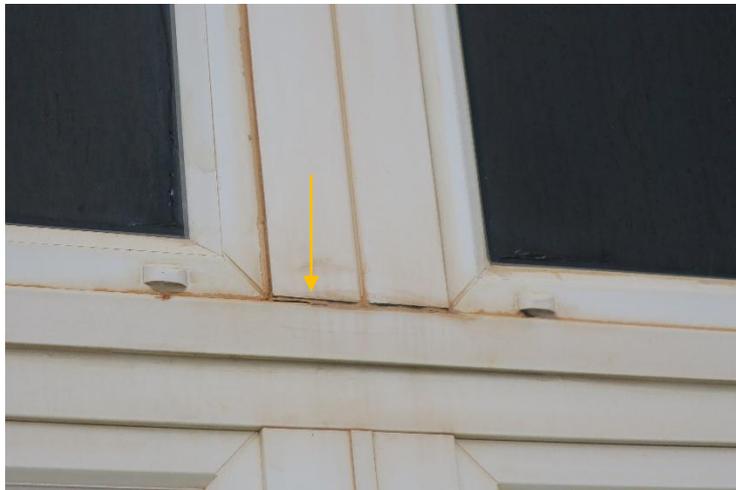
Inspecting externally, the window unit has a spandrel panel at first-floor level, and the mastics around the window unit and at the junction between the window and the spandrel panel have split.

uPVC windows will also allow water to collect in the frames, as they are hollow.

In terms of remedial works, re-sealing all of the mastics to the windows initially should reduce the amount of water ingress occurring, although in strong storm conditions, it is believed that the windows will allow water ingress through the junction with the gaskets.

Ultimately therefore, over the longer period, replacement of the window unit will be necessary, and it would be worth considering replacement in thermally broken aluminium, or similar, to provide a more robust window unit, and also one that is not hollow on the frame.

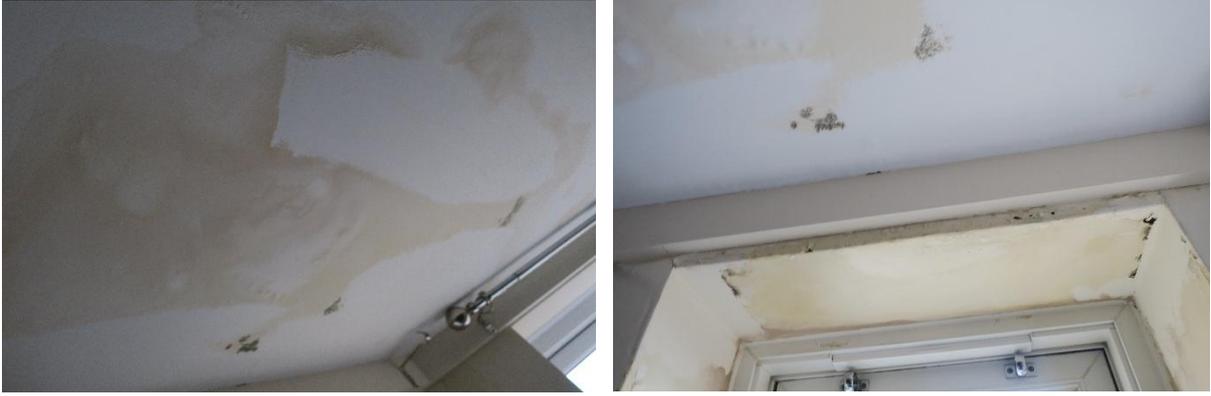
Flats 11 & 12.

Both flats are suffering from water ingress through the head of the bay window, with dampness extending in across from the splayed window in Flat 12, extending on the ceiling and to the head and sides of the window.

As Flats 11 & 12 are showing signs of failure leaking across the ceilings and not just above window heads, this is considered more likely to be a problem with the leadwork forming the balcony waterproofing. Whilst lead is a good material, there are now products specifically designed for balcony systems such as Westwood Industries Wecryl 230 system or Triflex.

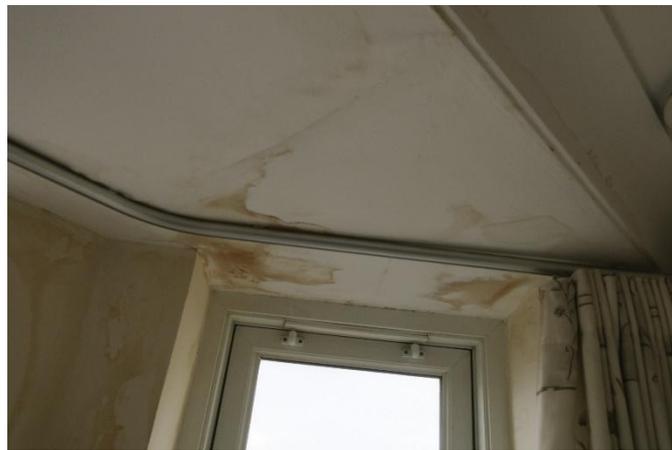
In Flat 11, the damp patch is apparent to the top corner of the window on the splayed bay window return.

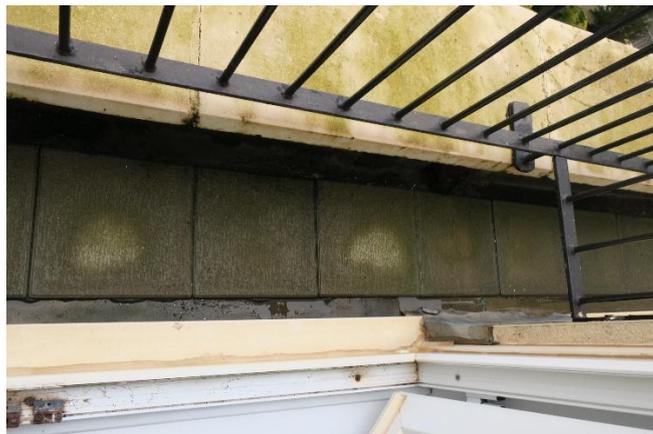
Due to the promenade tiles, most of the lead sheet is not visible, although the box gutter does appear to be leaning backwards towards the building, and it is provided with a proprietary expansion joint.

There is a minor gap to the corner of the leadwork on the balcony of Flat 17, although water also appears to be entering on the parapet.

In order to detail correctly, we would recommend that the coping stones are also lifted as part of any re-roofing works so that the roof membrane can be dressed up and across the top of the cavity walls to fully encapsulate the wall to roof detail.

As part of any re-roofing scheme, the patio doors should be removed so the balcony membrane can be dressed up and over the threshold, and a lead tray can be installed under the doors to protect against water penetrating down through the door.

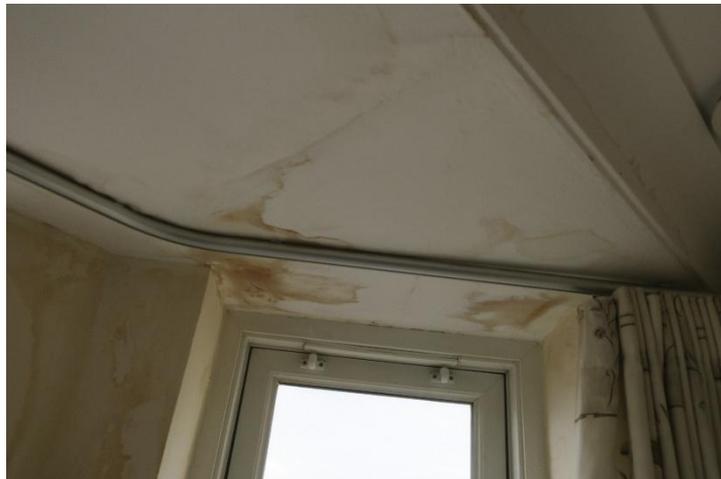
Flat 13

Flats 13 is located on the 2nd floor and is, again, suffering from problems with water ingress around the bay window. Damp staining is apparent each side of the central window, with the ceiling being damp stained. We were also advised that rainwater drips into buckets following rainfall on the right-hand splayed window when looking out. There is also damp running across the beam which spans the width of the bay.

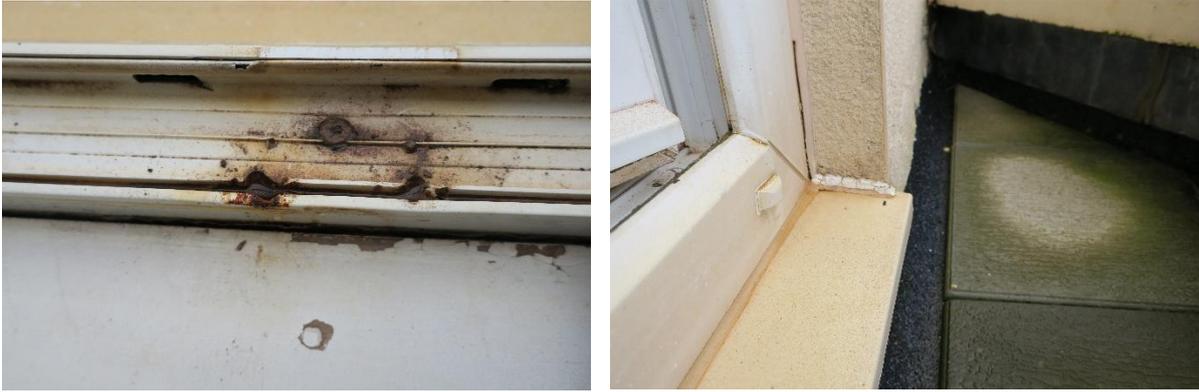
The doors serving this balcony do appear to be leaking, with the mortar eroded around the sides of the doors.

In addition, the upstand height to these doors is low, being approximately 70mm, and the British Standard for roof upstands requires a minimum of 150mm.

The leaking doors will unlikely however cause the damp staining above the head of the main windows, which is more likely to be a detailing issue where the balcony meets the perimeter walls, and potential cavity tray failure.

Again, we would recommend that the roof covering is stripped, with the coping stones being lifted so that the balcony waterproofing can run up and over the perimeter walls. In addition on this, we recommend the door set is replaced, and when it is reinstalled, it is installed over a lead tray to provide additional protection. The waterproofing system should also run up and over the threshold to the door aperture.

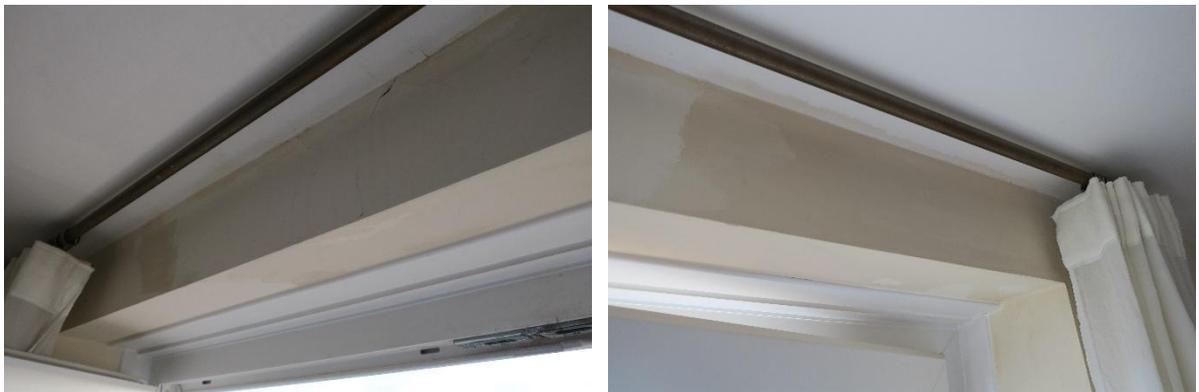
Flat 16 has water ingress running along the top of the double doors, which may also be contributing to the water entering Flat 11 beneath.

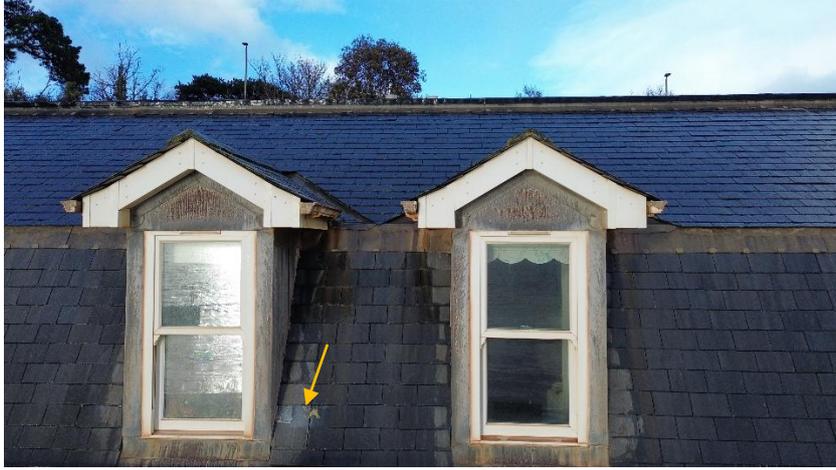
There is a slate missing at roof level and this could be the source of water ingress if the sarking felt is not lapped correctly over the lead forming the box gutter.

As access will be required to replace the missing slate, we recommend the box gutter is checked for any blockages or failure when access provisions are available.

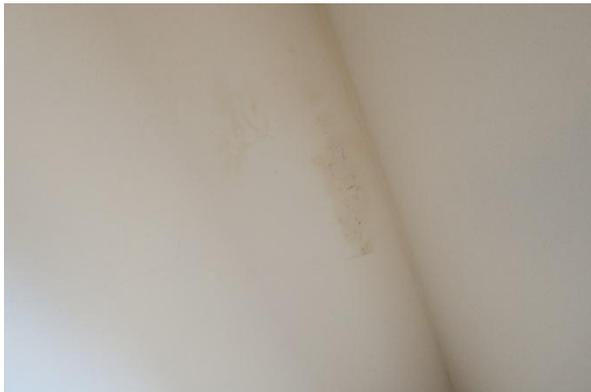
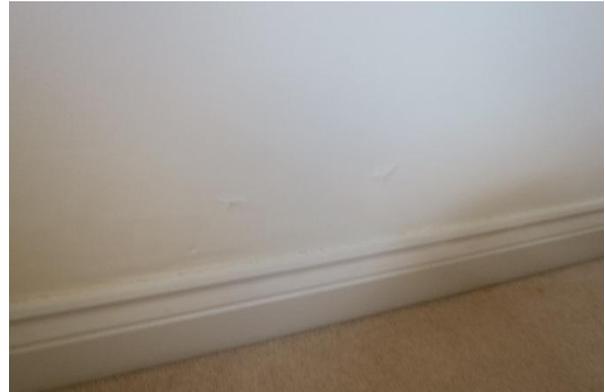
Flat 20 is a top-floor flat built within the mansard roof and is suffering from longstanding damp issues to the side of the mansard, and also to the flank wall in the living room. Damp levels to the side of the mansard were however a maximum 44%, with the dampness to the side elevation wall being between 19% and 23%, which is a reduction on when we last inspected.

Bearing in mind we inspected after a long period of storm weather, the damp levels were not particularly high, therefore previous repairs do seem to have improved matters.

There is nonetheless still some residual damp left over.

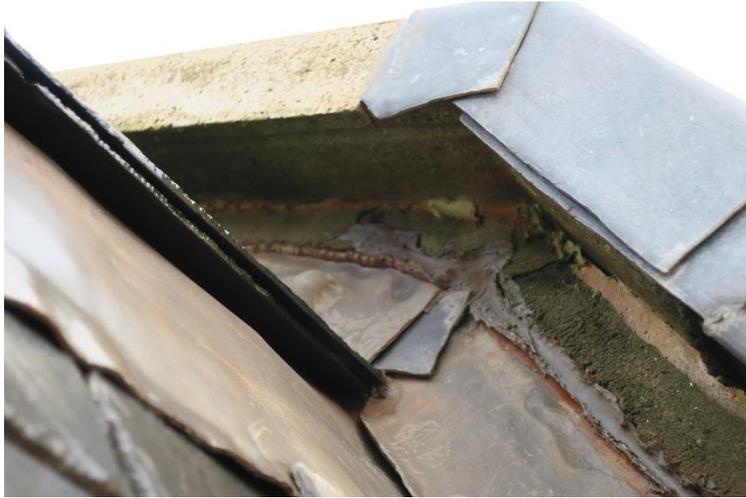
On the side of the mansard with the party wall, the mortar underneath the coping is cracking and would benefit from being raked out and re-pointed.

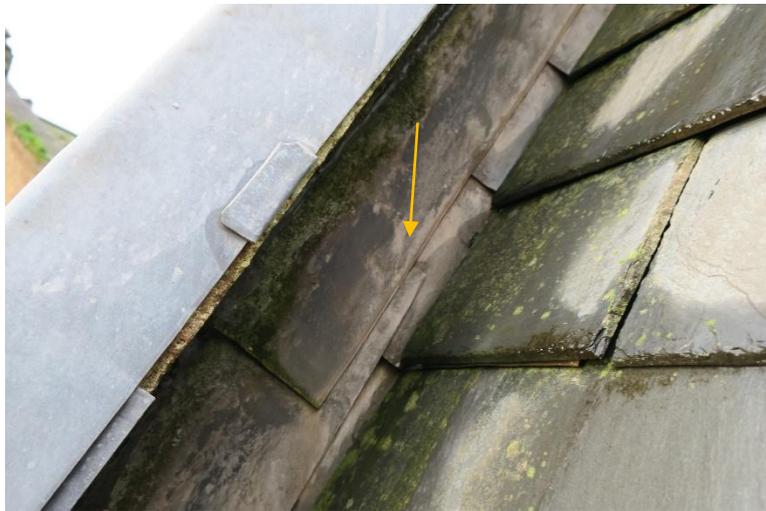
On the side wall side soakers on the roof do appear to be installed with an incorrect lap, and stripping out and replacing the soakers at this abutment would be beneficial.
