REPORT ON LEAKING BALCONIES

AT THE PROPERTY KNOWN AS

Great Cliff
Marine Parade
Dawlish
EX7 9EX

Date of Inspection: 8 January 2019

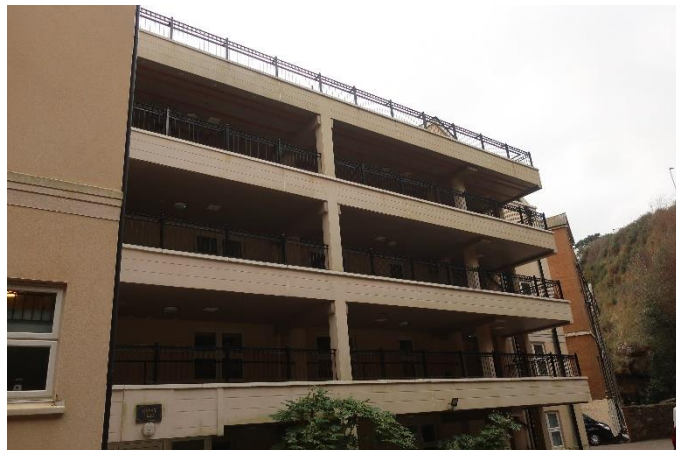
The problem in relation to the balconies is apparent on the rear elevation only as the rear elevation is provided with a central stairwell and open balconies and entrance landings being provided to give access at each floor level.

The balconies appear to be constructed with a Bison style pre-cast concrete support slab, being covered with asphalt to the upper face and provided with promenade tiles in the areas where the walkways are provided.
